London Borough of Hammersmith & Fulham

6. **HAMMERSMITH LIBRARY REFURBISHMENT AND OPTION FOR
ARCHIVE SERVICE**

Feasibility Report for the Upgrade of Hammersmith Library, Shepherds Bush Road, Hammersmith, London W6 7AT

June 2012

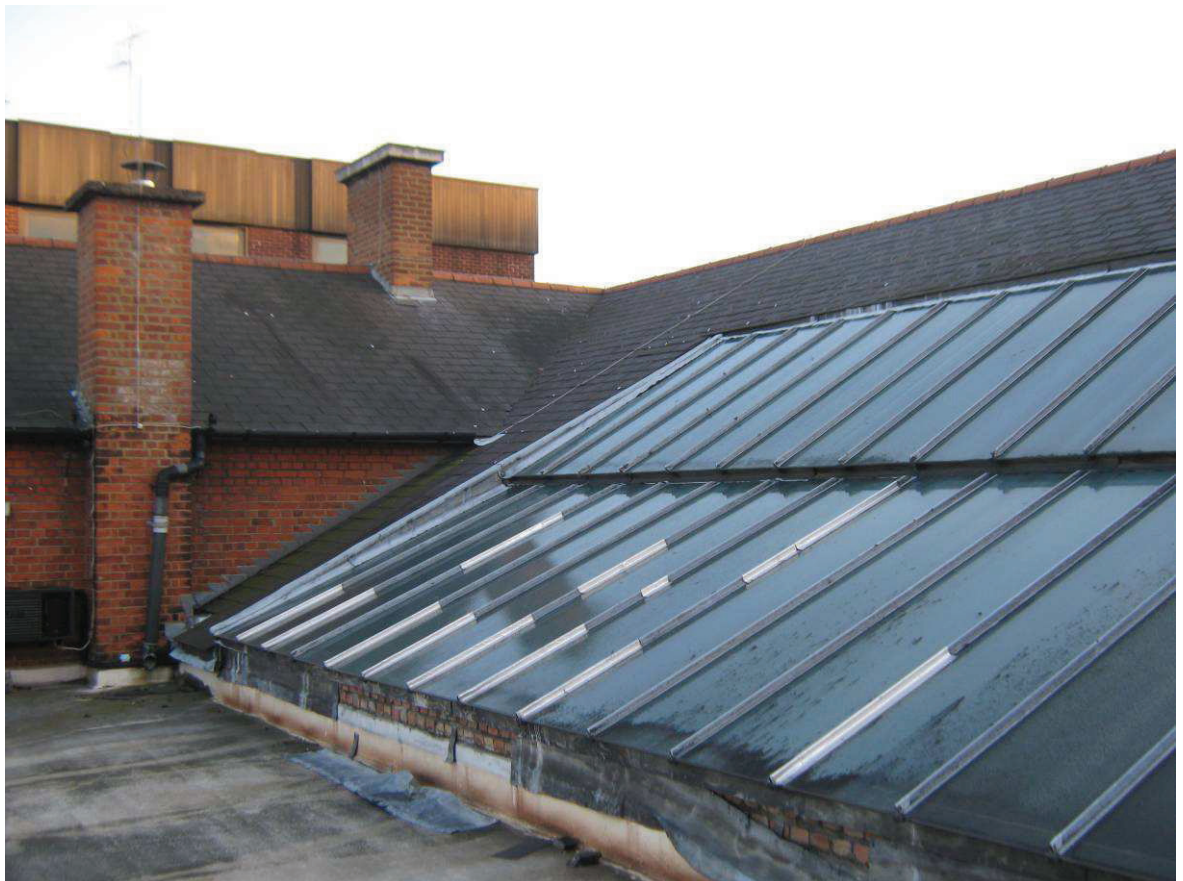
- 4.9 The east facing (rear) elevation of the main roof includes a roof light (photograph 2) which provides natural light to the main library area on the ground floor. The following issues were noted in respect of its condition:

- a) Nine of the twenty glazing bars have received repairs in flashband.
 - b) The flashings at the abutment between the upper and lower sections are torn.

Photo 2. Roof light over glazed vault to ground floor

- The most significant issue in respect of the exterior that will require consideration is associated with the renewal of the main roof light that serves the ground floor library area. We recommend replacement due to the extent of the repairs that appear to have already been carried out although this proposal is subject to the outcome of discussions with the conservation officer and review of the health and safety issues associated with this work.

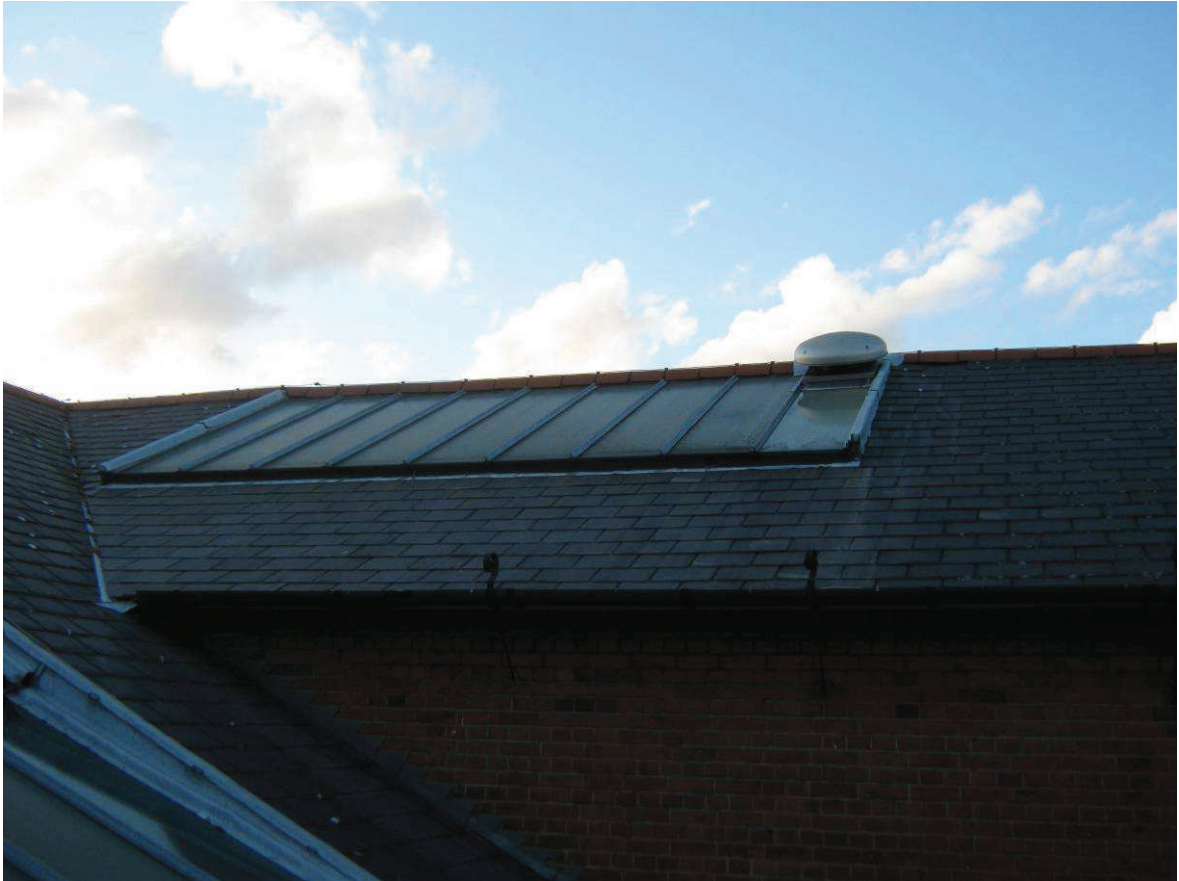
Photo 3. Roof light over reference library

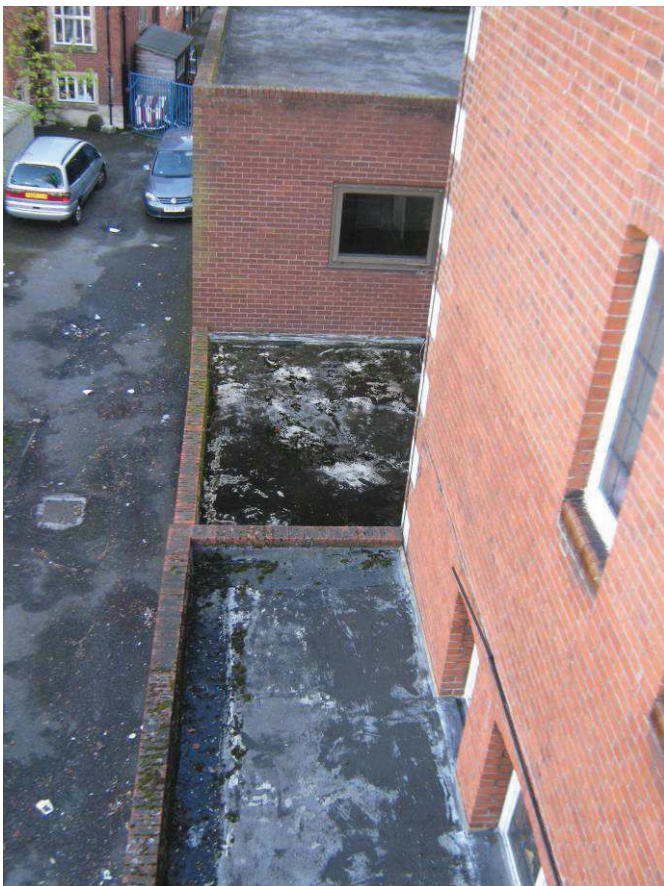
Photo 6. Flat roof over the staff entrance

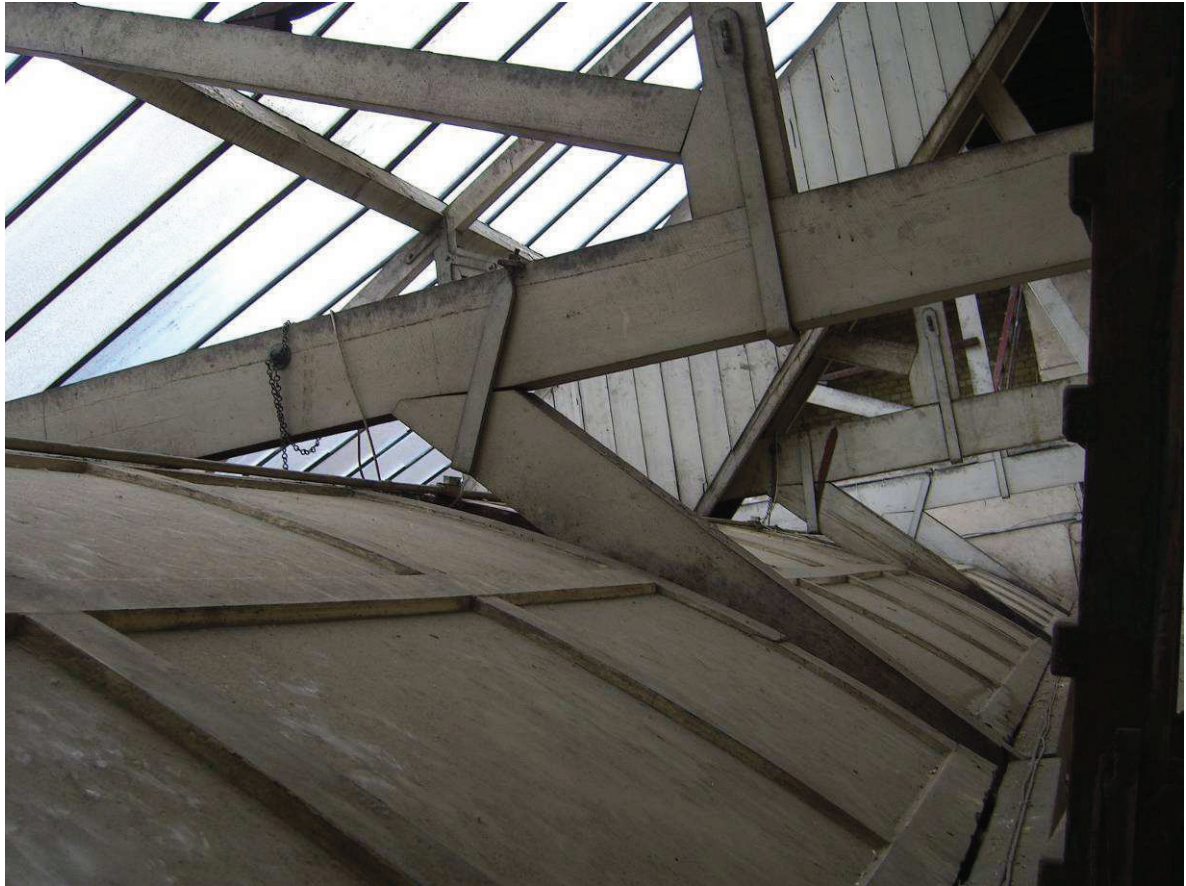
Photo 7. Roof void between roof light and glazed vault over ground floor

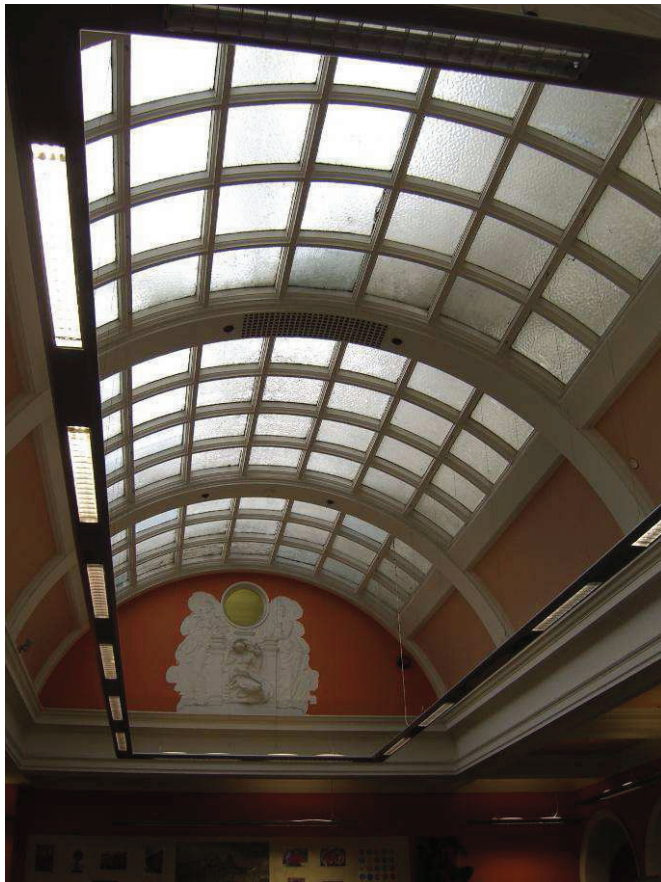
Photo 8. Glazed vault over main ground floor area of library

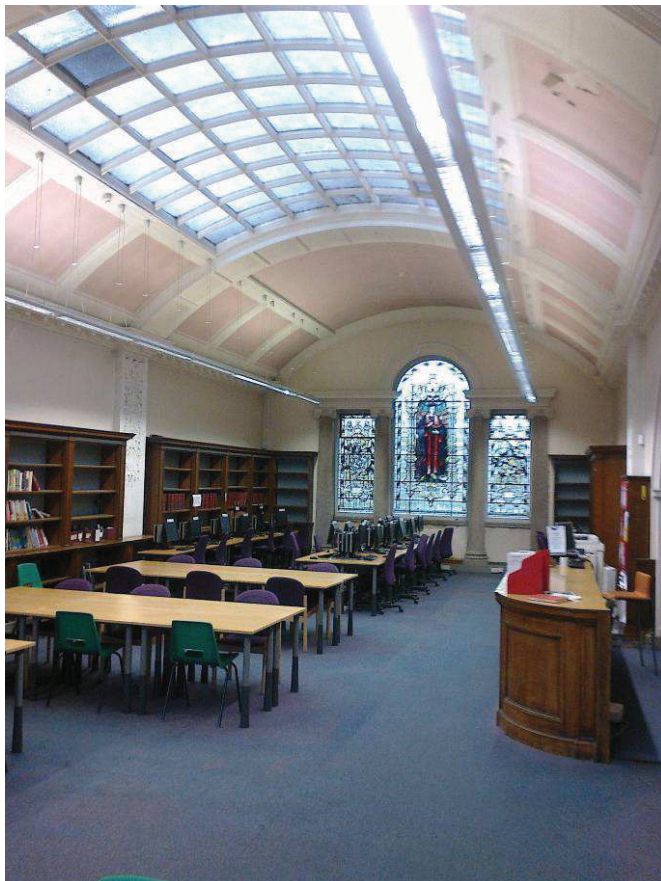
Photo 10. Reference library on first floor

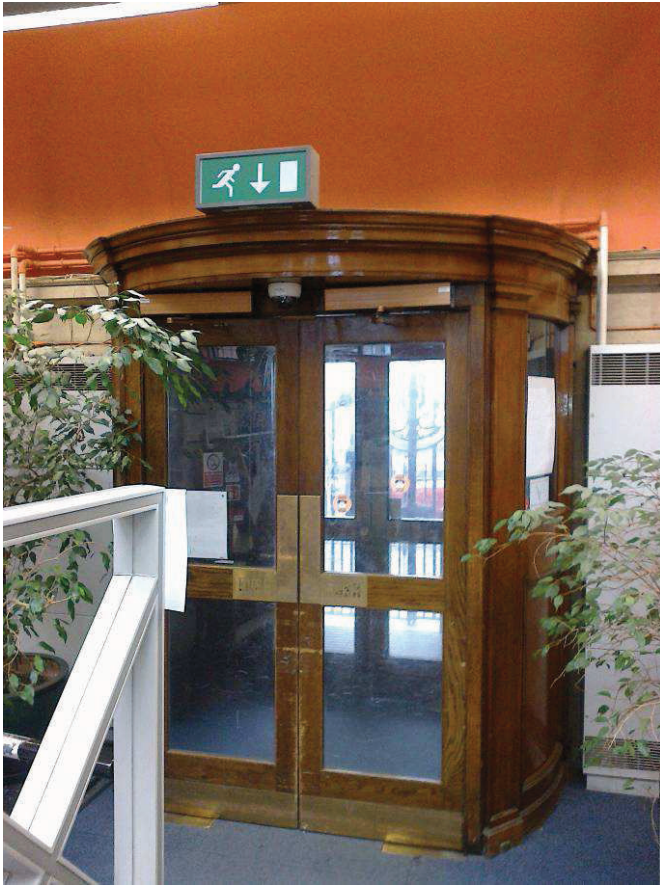
Photo 11. Public entrance to the library

- Although we recommend the replacement of the automated entrance door and the operating mechanisms we propose that the existing lobby be retained with the doors only being renewed.

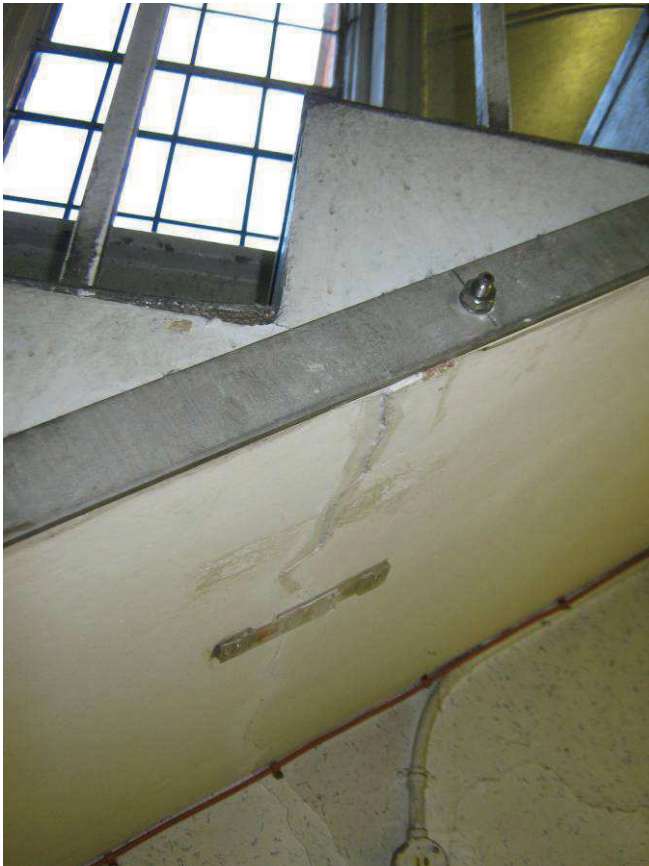
- However, there two issues associated with the structure that are subject to further investigation:
 - There is cracking in the soffit of staircase 2 and the adjacent external wall at first floor level. This is currently being monitored and we are awaiting the outcome of these investigations.
 - There is cracking in the wall over the door opening to the children’s library which requires further investigation.
- We also recommend that consideration is given to replacing the existing fire doors with doors that meet the current certification requirements and we have also included costs in the feasibility below.
- We recommend that further investigations are carried out to find out the causes of dampness within the basement. However, we have a budget cost for tanking of the walls in staircase 2 and room 3 in the basement.

Photo 12. Cracking to soffit of staircase
