London Borough of Hammersmith and Fulham

Feasibility Report for the Upgrade of Hammersmith Library, Shepherds Bush Road, Hammersmith, London W6 7AT

June 2012

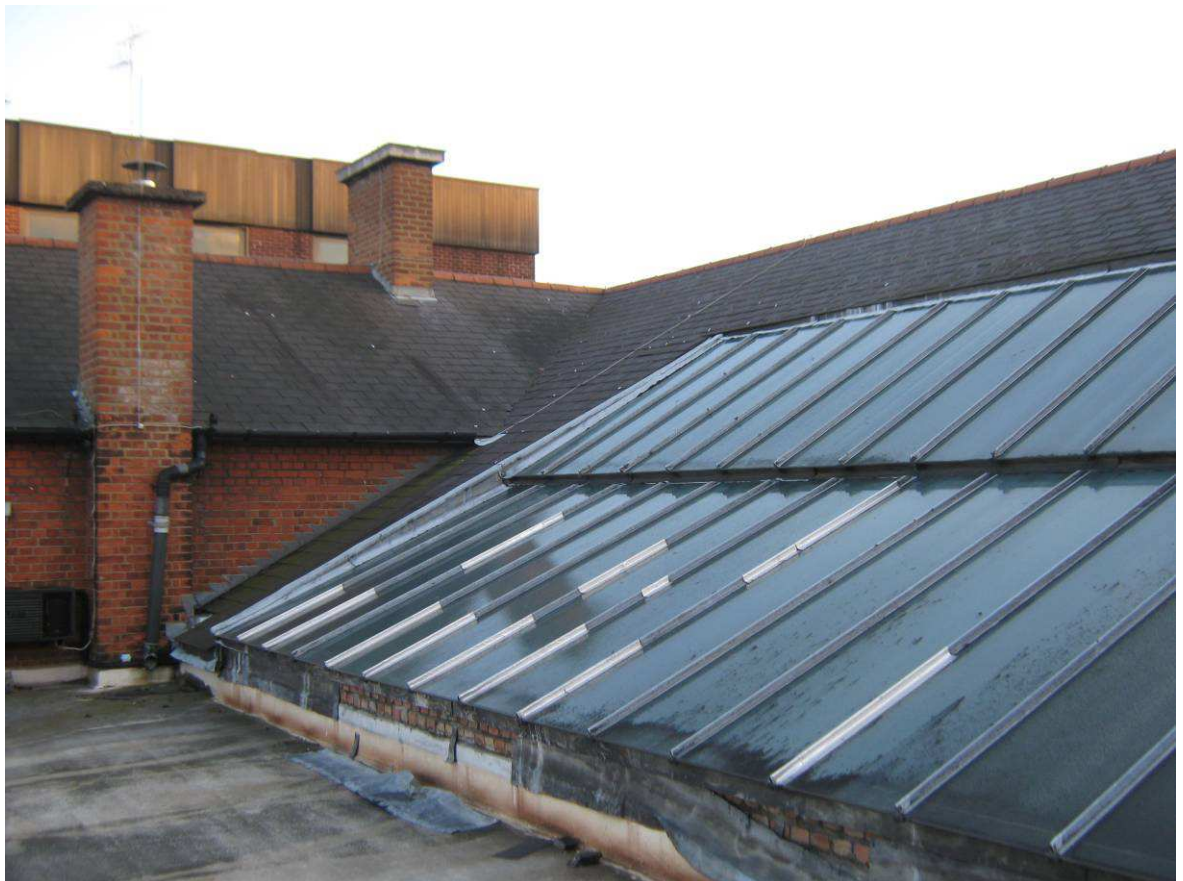
- 4.9 The east facing (rear) elevation of the main roof includes a roof light (photograph 2) which provides natural light to the main library area on the ground floor. The following issues were noted in respect of its condition:

- a) Nine of the twenty glazing bars have received repairs in flashband.
 - b) The flashings at the abutment between the upper and lower sections are torn.

- c) Four of the glazed sections are cracked.
 - d) The lead flashings on each side of the rooflight appear to have received a coating of a water proof coating indicating that there have been problems of water penetration in the past.

- e) The rooflight is supported by an upstand wall with a lead flashing dressed under the bottom of the glazed section. However, lead flashing has slipped from under the rooflight and requires replacement.

Photo 2. Roof light over glazed vault to ground floor

- 4.10 We recommend that the roof light is replaced although it will be a building regulation requirement that it should be replaced with a double glazed unit. It is likely that the conservation officer will object to this when an application for listed building consent is submitted and that Building Control may agree to the replacement with a single glazed rooflight.

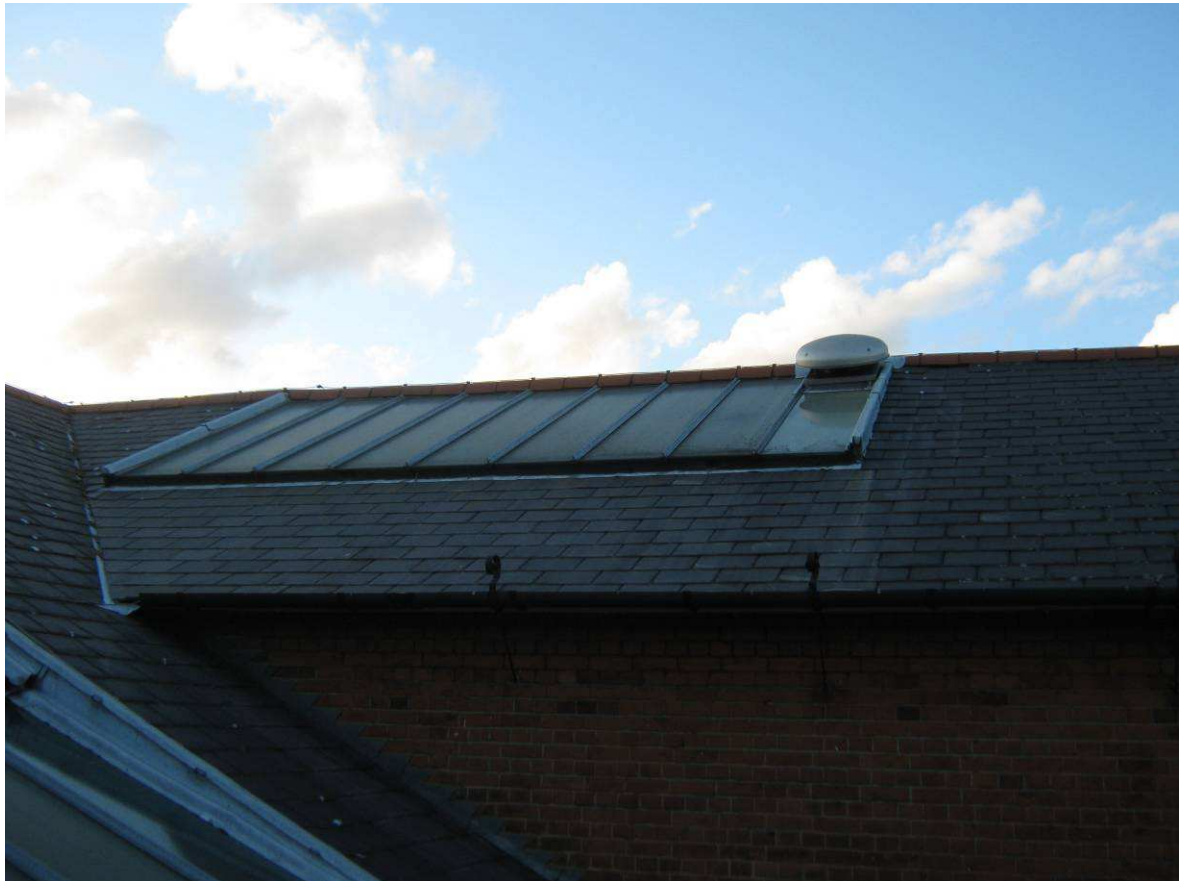
- 4.13 There are also roof lights on each side of the pitched roof over the reference library (photograph 3). Although there was insufficient access to enable us to properly inspect the condition of these we do not propose to carry out any remedial works to them. However, if LBHF did wish to carry out preventative maintenance works at this stage we recommend that consideration is given to applying a liquid coating such as Decothane Clearglaze by Liquid Plastics since they do not appear to have suffered the same level of deterioration as the rooflight serving the main library area on the ground floor.

Photo 3. Roof light over reference library

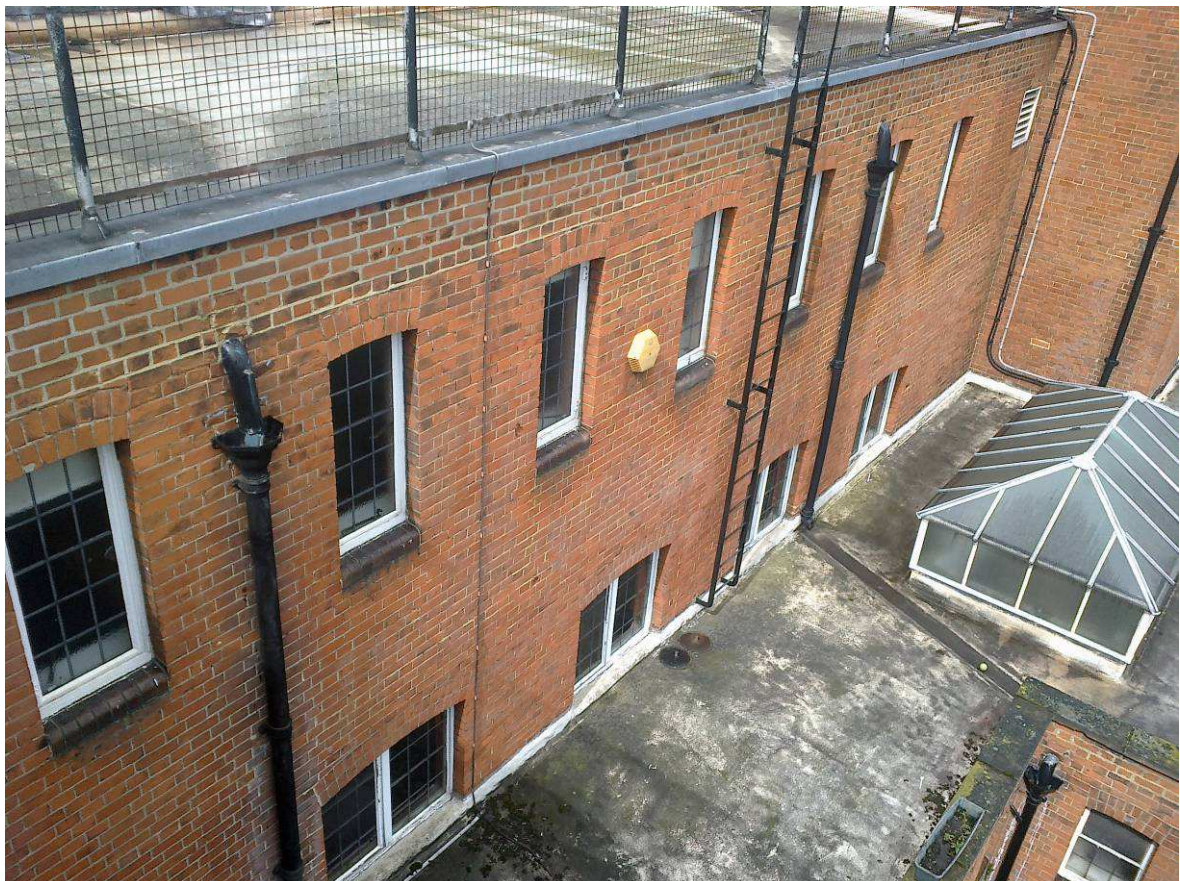
- 4.15 Although not outlined on your brief we recommend that further remedial works are carried out to the flat roofs (photographs 2, 4, 5 and 6).
- 4.16 The asphalt flat roof over the first floor is generally free of splits tears and bubbles although the solar reflective paint finish is beginning to crack.

Photo 4. Rear elevation

- 4.18 However, the application of the original asphalt roof coverings did not take account of the need to allow for differential movement between the concrete slab and the walls although at this stage the only defect that is visible is a crack in the abutment between the flat roof and the upstand to the rooflight. On this basis we recommend that the asphalt skirting is cut out and renewed throughout the whole of the flat roof.

- 4.19 Following the renewal of the asphalt upstands and lead flashings we recommend that two coats of solar reflective paint are applied to the roof covering to provide protection against the sun and prolong the life of the asphalt.

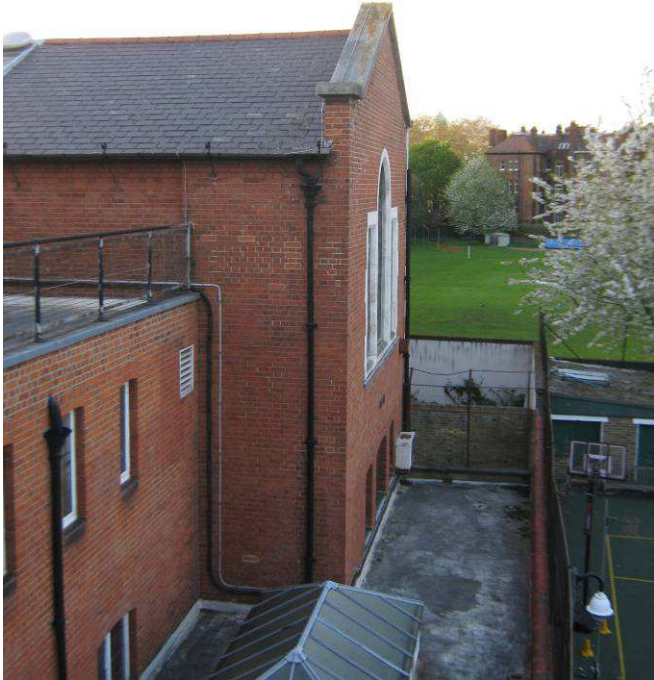
Photo 5. Rear elevation

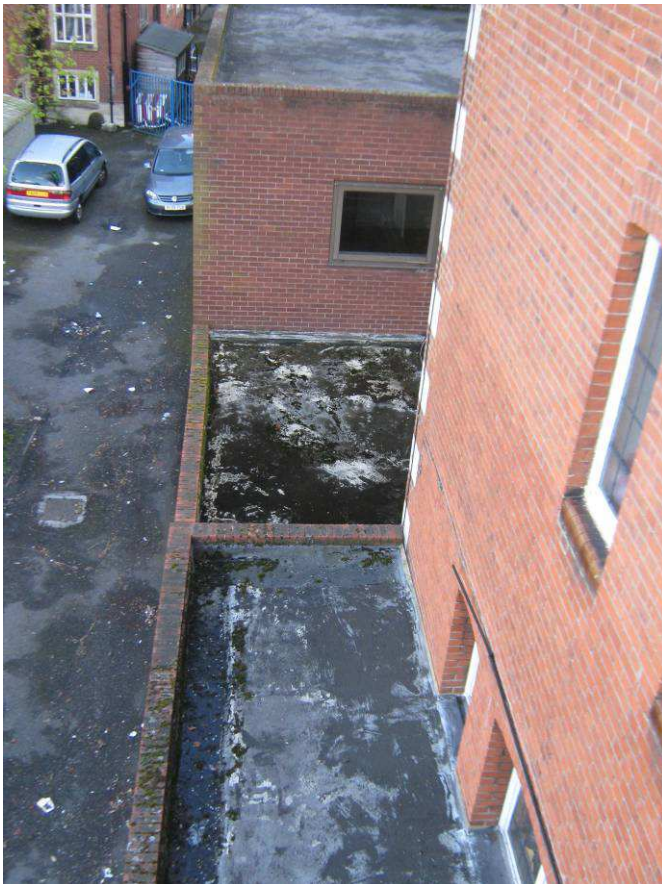
- 4.21 However, the flat roof coverings over the staff entrance lobby and corridor are in a more severe state of repair (the asphalt upstands have detached from the wall and slumped and the flat roof covering is rippled) and we recommend that these roof coverings are replaced.

Photo 6. Flat roof over the staff entrance

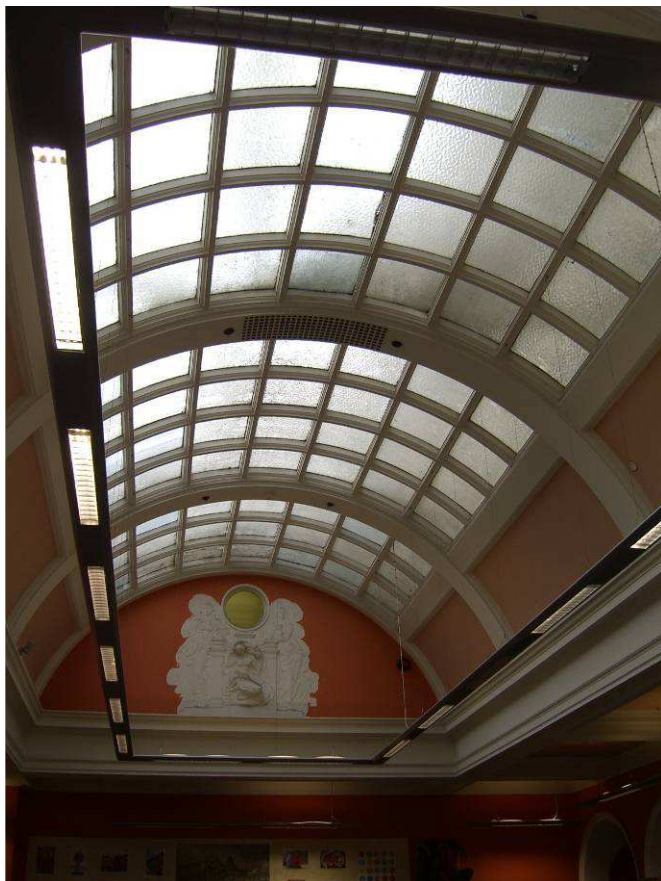
- 4.47 The interior of the library areas (photographs 8, 9 and 10) comprises principally of a painted walls and ceilings although the walls to the main public staircase are clad in marble up to the handrail height. The finishes to the main public areas on the ground and first floor and the Chief Librarian's office are particularly ornate and include cornices etc and overall the interior of the premises is in a fair state of repair although the decorative finishes to the staff offices are now very tired.

Photo 8. Glazed vault over main ground floor area of library

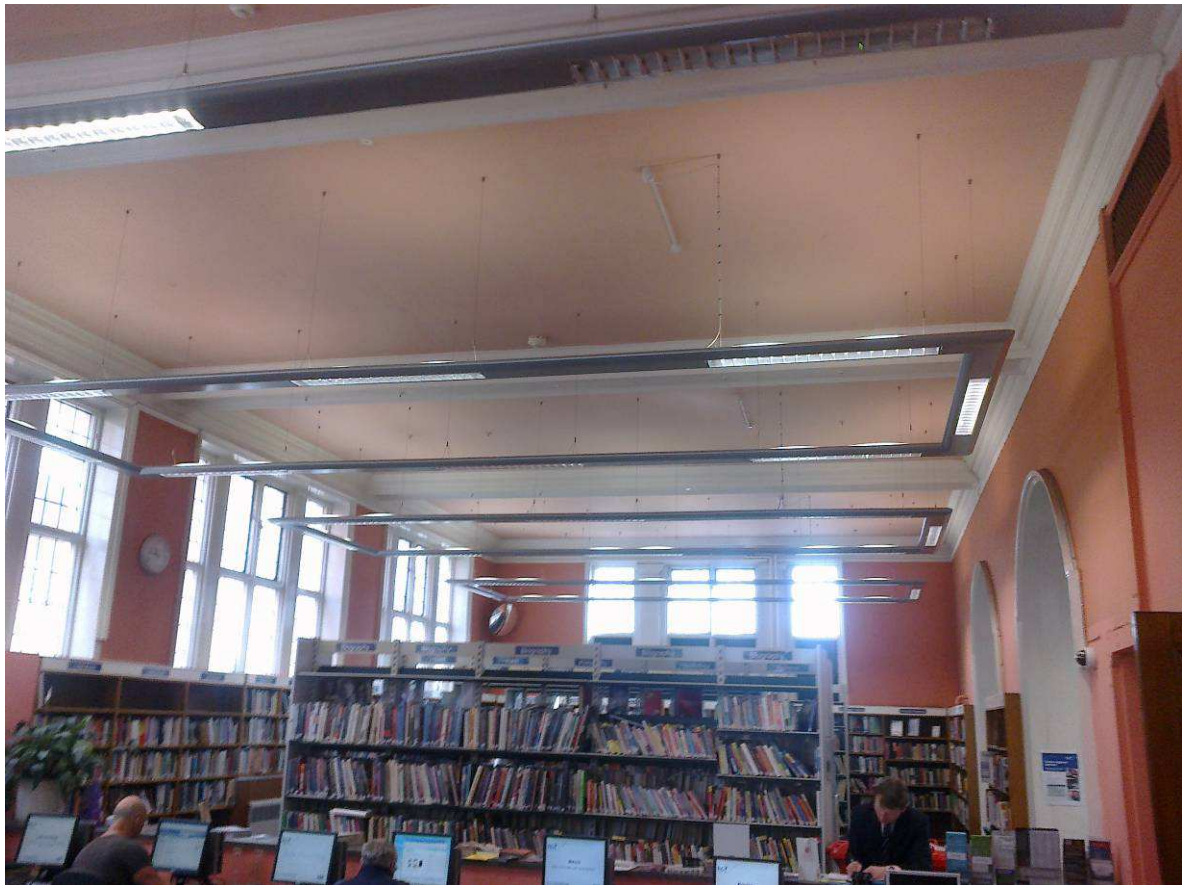
Photo 9. Study area and non fiction section – ground floor

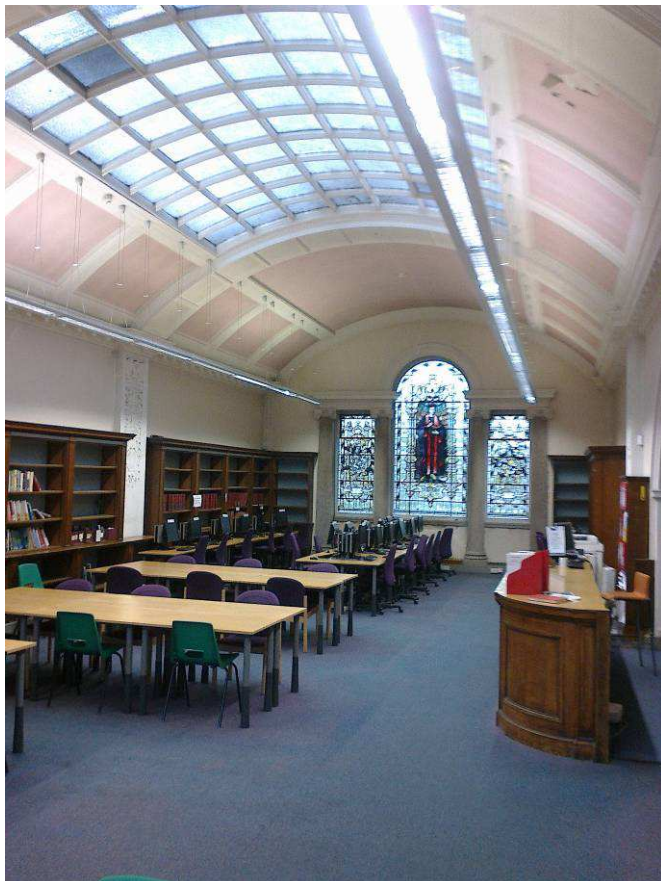
Photo 10. Reference library on first floor

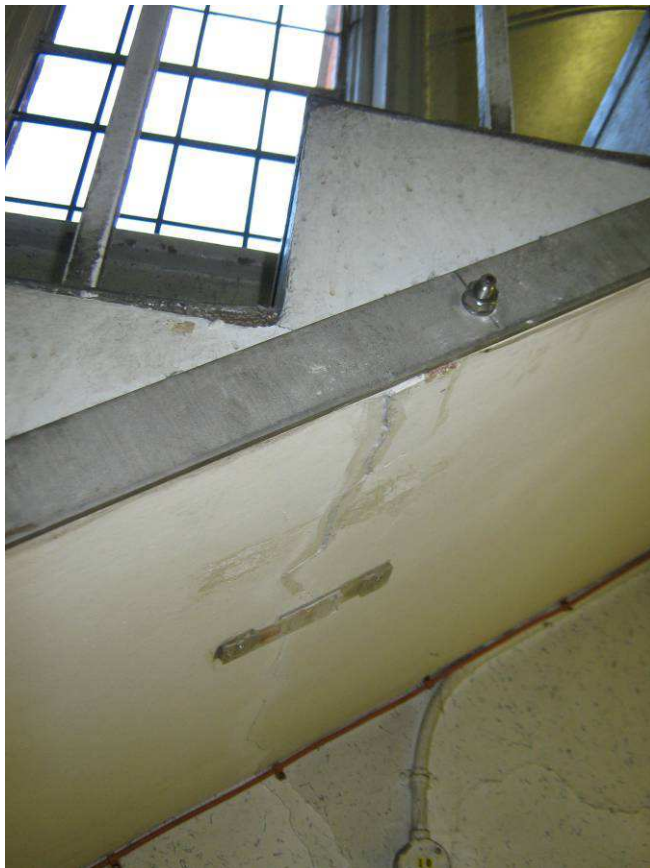
- b) There is ongoing monitoring of cracking to the rear staff staircase which is reported to have been taking place over the last six months. Tell tales have been placed over a crack in the wall and to the soffit (photograph 12) to the staircase at first floor level. The location and pattern of the cracking in the wall is not consistent with a problem such as a subsidence or structural failure although the cracking in the staircase requires further investigation, particularly as the concrete is very thin.

Photo 12. Cracking to soffit of staircase
