Condition Survey and Planned
Maintenance Schedule

Sullivan Primary School

Edward Hawkins BSc (Hons) MRICS

Date: 9th September 2013

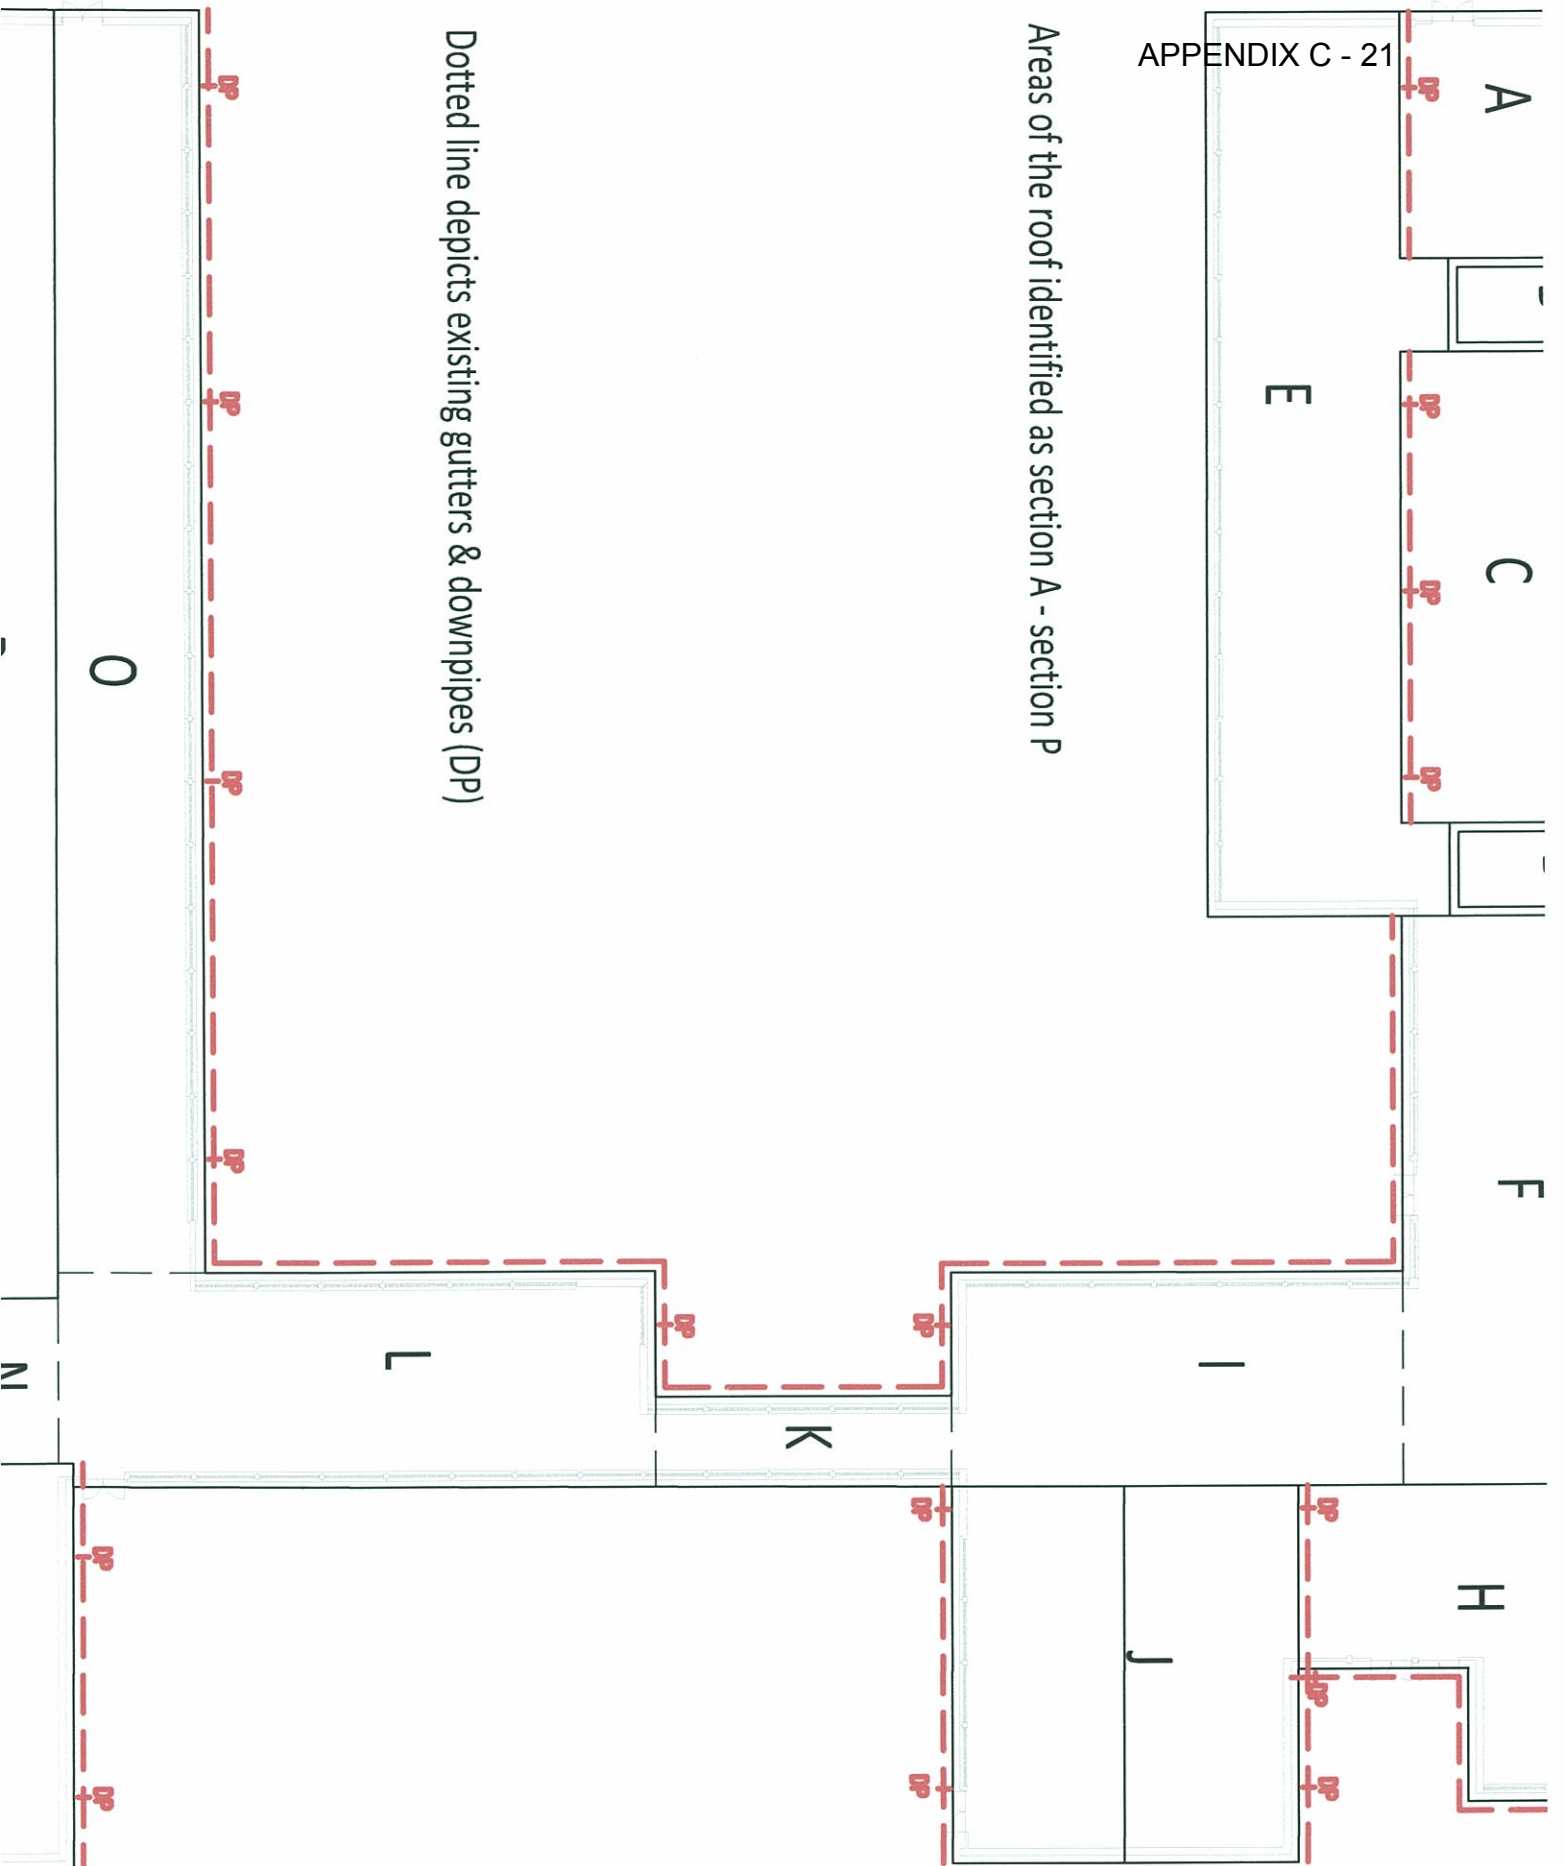
Areas of the roof identified as section A - section P

Dotted line depicts existing gutters & downpipes (DP)

The guttering to the various roofs is slightly undersized and during extremely heavy rainfall water can overflow the gutters in specific areas. This issue would be relatively easy to remedy and could be undertaken in phases should funding be an issue, an allowance of £20,000 would cover the cost of these works.
