Conditions Summary Report at
Sullivan

London Borough of Hammersmith and Fulham

Condition Summary Report at Sullivan Primary School

16 September 2013

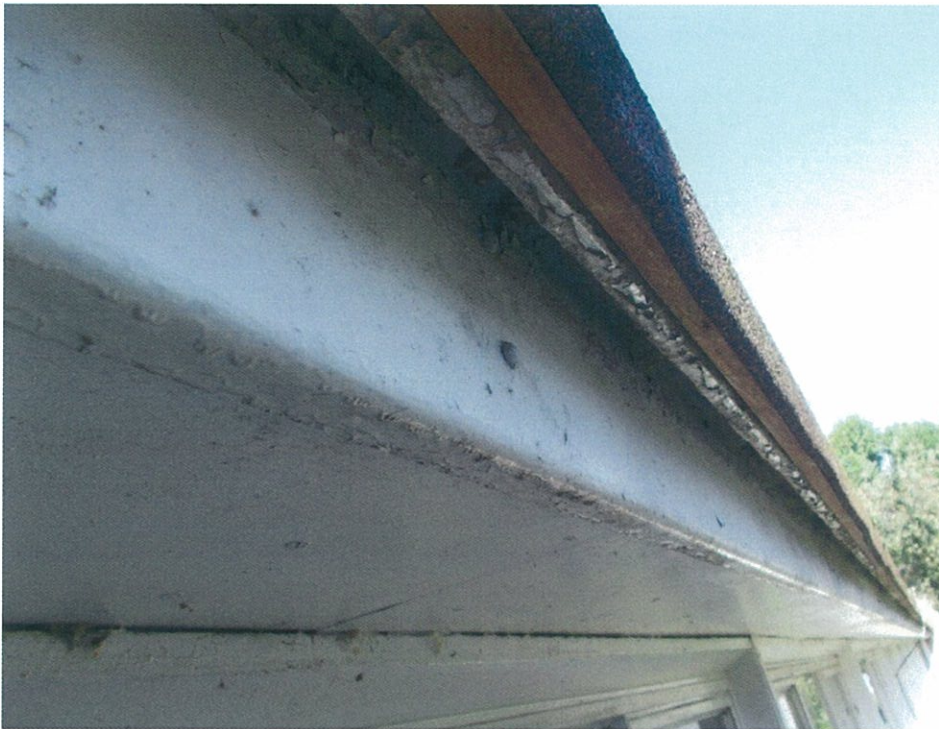
Existing fascias are painted profiled metal and existing soffits consist of painted boards. The paint coatings to these elements are failing and metal elements are in-part corroded. As installation of insulation is required under the Building Regulations in renewing the roof coverings, this will result in an increase in depth to the roof surface. Therefore, new fascias are required to be installed to accommodate the increase in depth. We recommend existing fascias and soffits are capped with PVC given their current condition avoiding the requirement for on-going cyclic redecoration works.

Photo 3 Example Condition of Eaves

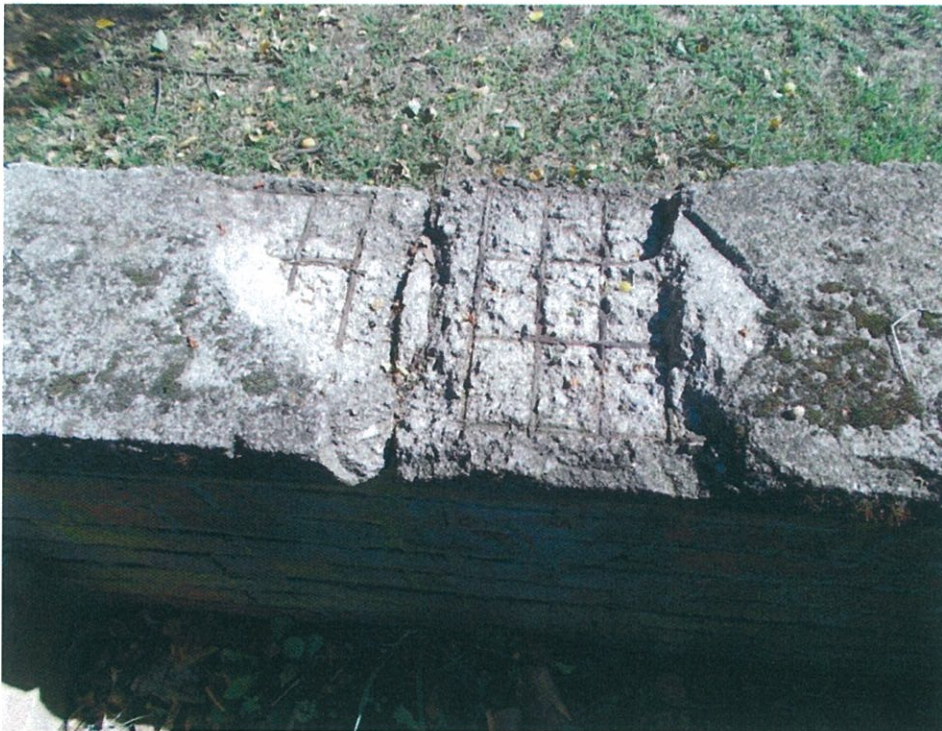
Photo 4 Example Condition of Concrete Copings

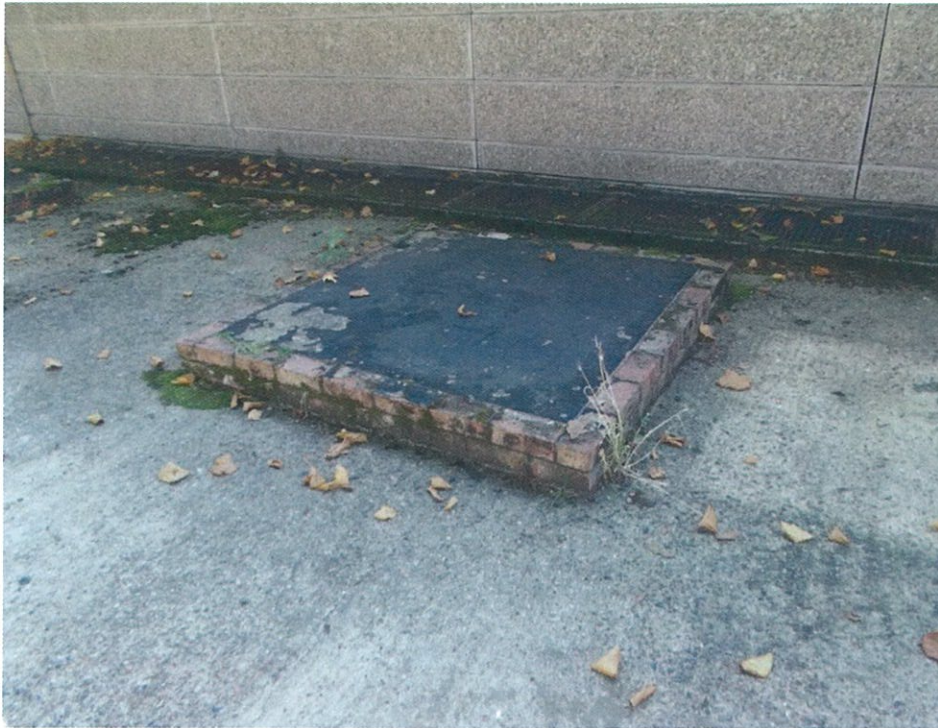
Low level brick surrounds are located to the hard standing North of the Canteen and are in a poor condition. Friable mortar and loose bricks identified should be repaired and made good. Additional waterproofing works may be required in these areas in order to mitigate water ingress into basement areas.

Photo 5 Basement Penetrations to North Hard Standing

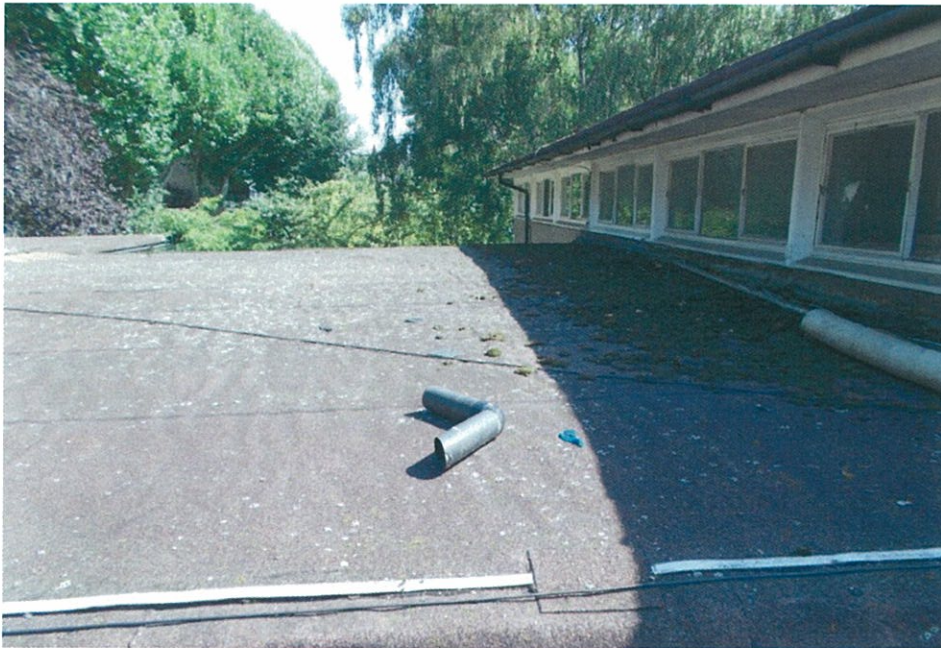
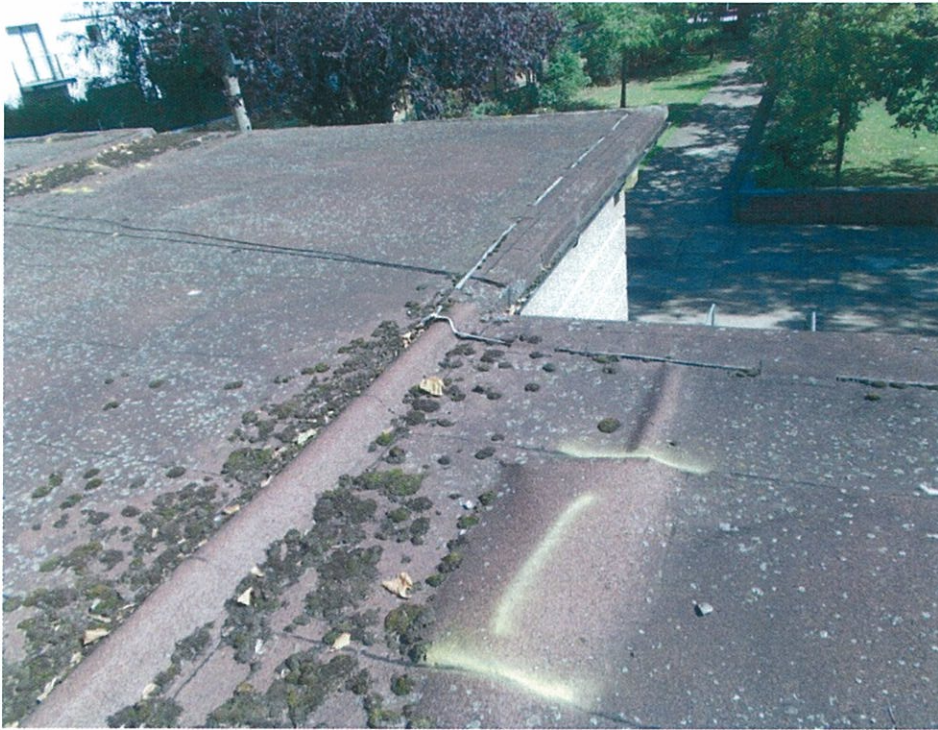
A majority of existing roof coverings we have inspected appear to be in a poor condition and are blistered and weathered. There is also evidence of water ingress internally. We recommend existing roof coverings are replaced within two years in order for School buildings to remain maintain wind and watertight. Should budget allocations not be available, roof patch repairs should be completed as a matter of urgency. It is important to note, in stripping and replacing existing roof coverings, it is a requirement under the Building Regulations to install insulation. This will improve thermal properties of roof structures and have the added benefit of reducing heating costs for the School.

Photo 6 Example Condition of Roof Covering

Photo 7 Example Condition of Roof Covering

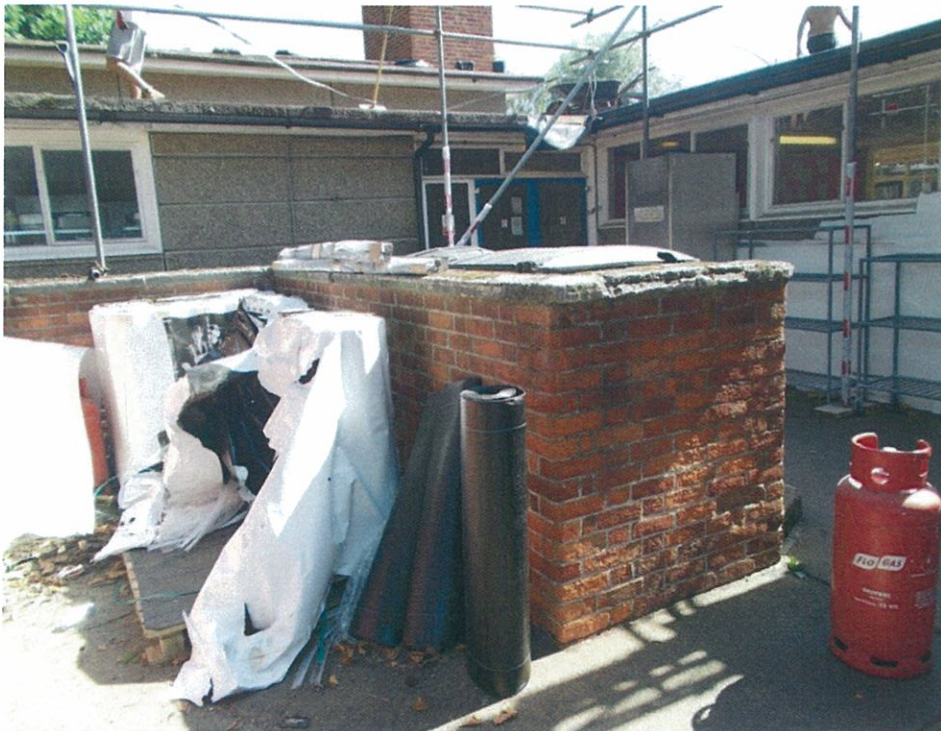
A bin enclosure North of the site (adjacent the basement staircase) is in a poor condition with heavily spalled brickwork subject to organic and efflorescence staining. Mortar to this structure is friable in locations and concrete coping stones are heavily spalled. Friable mortar, spalled brickwork and coping stones should be renewed within the next 2 years. We also recommend a damp proof membrane is laid beneath coping stones during repair works preventing water ingress that causes staining.

Photo 8 Brick Bin Enclosures

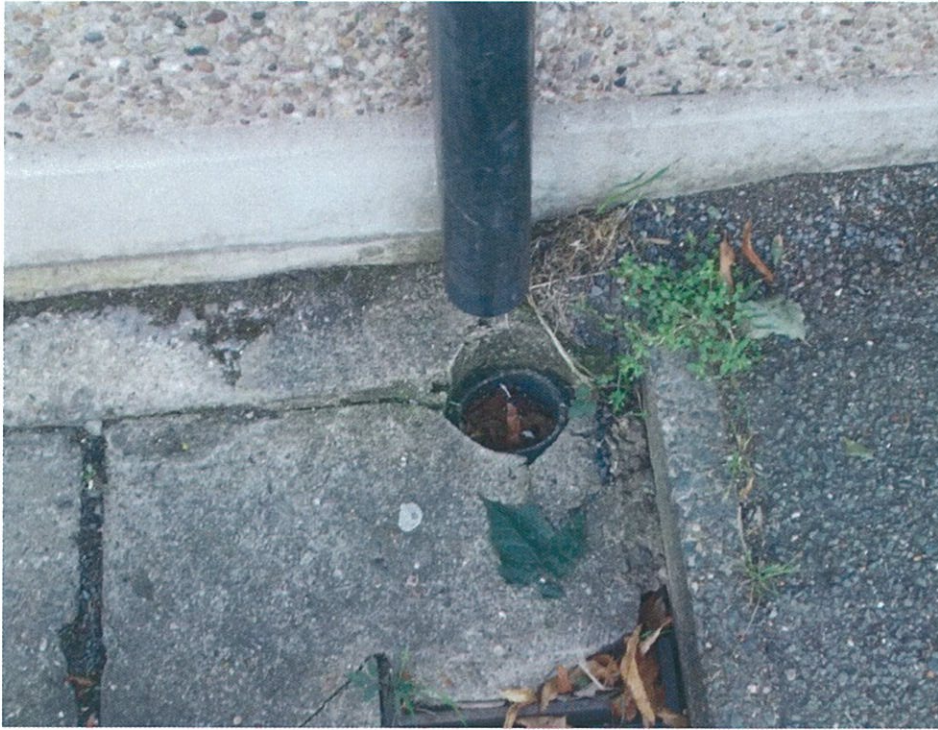
Gutters and downpipes are UV faded and leaking in various locations indicated by organic staining to joints. A build-up of debris was recorded within the gutters and gutter sections were noted not to be securely fixed due to loose and/or missing brackets. Isolated PVC downpipes are broken at bases where penetrating ground level.

Photo 9 Example of Broken Downpipe

Given the size of the roofs, rainwater goods are undersized and are unable to deal with high volumes of water. Due to this fact and given their age, rainwater goods should be replaced during roof replacement works.

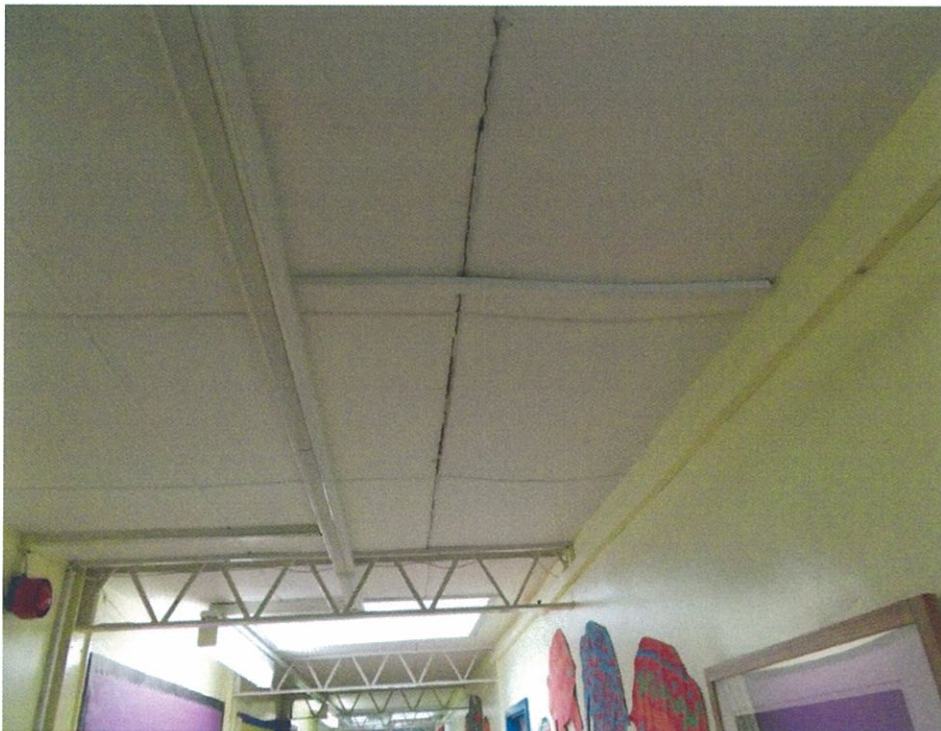
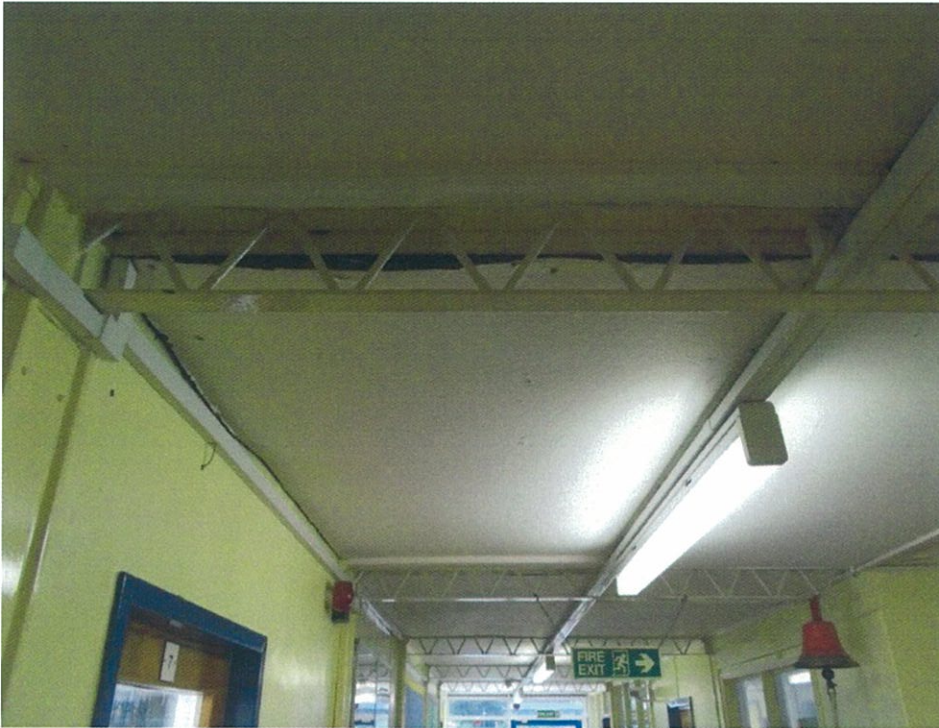
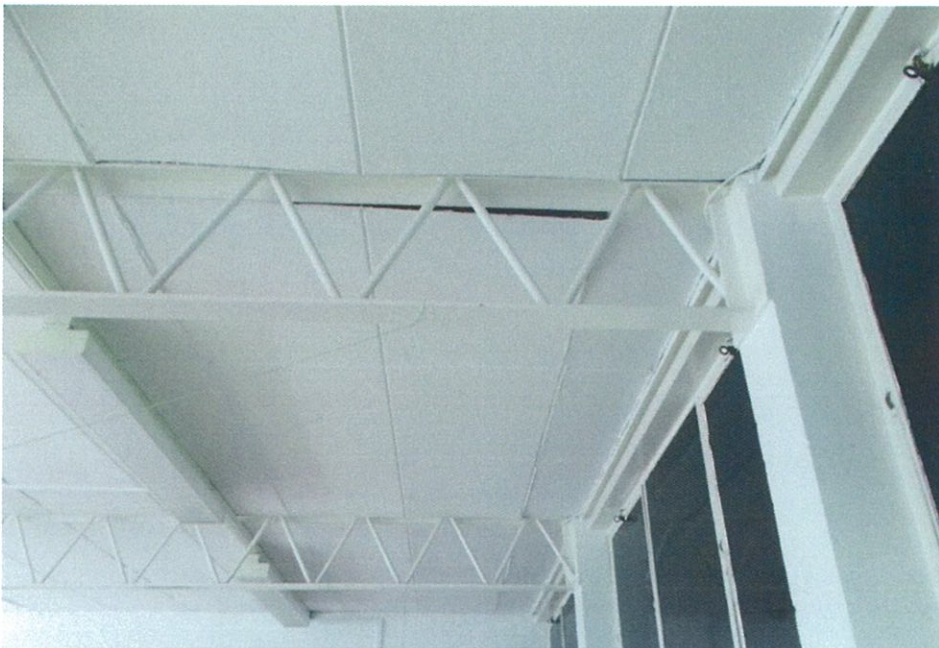
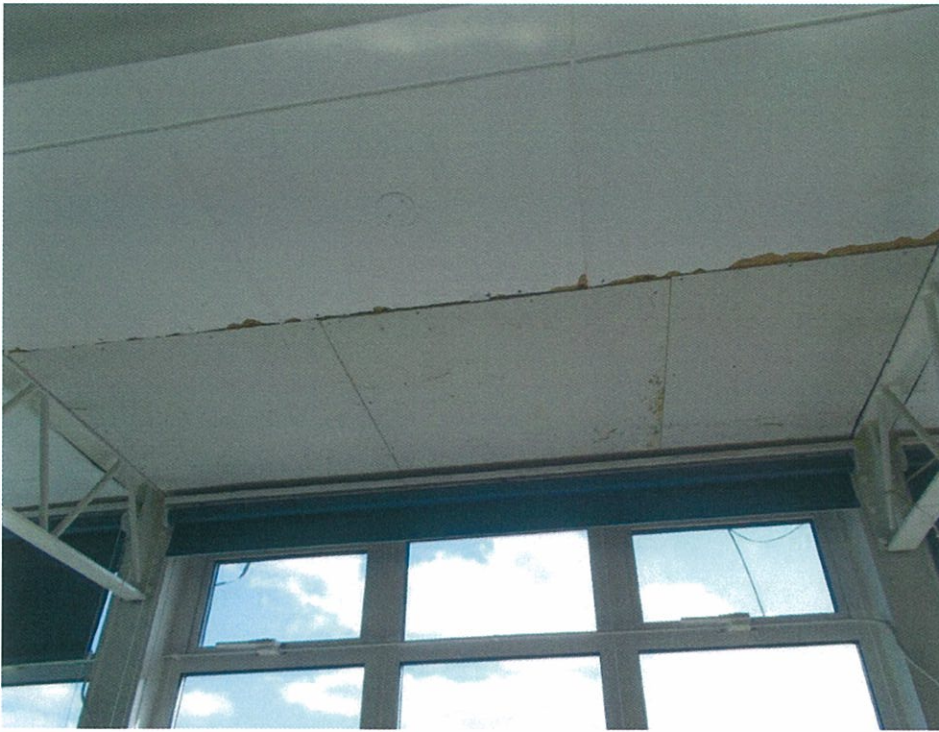
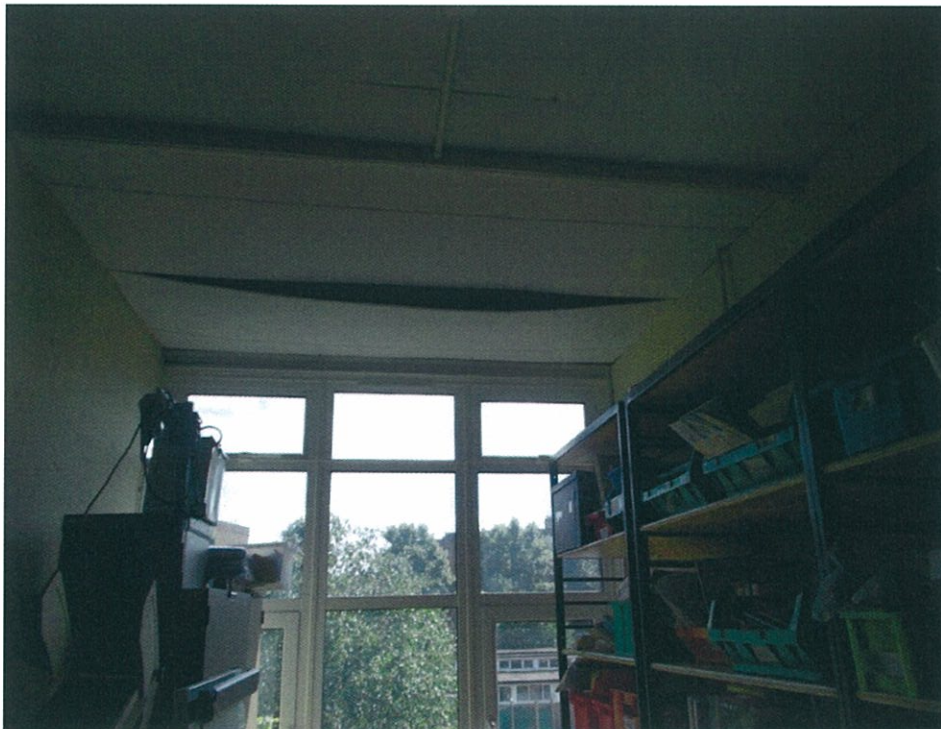
In many locations, it is evident ceiling board fixings are failing presenting a significant health and safety risk due to potential of ceiling boards falling from height. Evidence of failing ceiling board fixings is widespread throughout the School. Ceiling board failure was particularly apparent within first floor areas of the North Wing and areas of the South Wing, notably in proximity to Mrs Christine Baxter's Learning Centre Office and Mrs B Aldridge's Office. In addition, bowing ceiling boards were noted within the North Wing in proximity to Rooms No.7 and 8. It is important to note, we recommend a detailed survey of all School fibre board ceilings is completed in order to determine their integrity. This detailed survey should include provision of access equipment in order to assess high level areas and, it may be a requirement for intrusive/investigatory works to be carried out. A refurbishment Asbestos Survey (intrusive) will be required in order for this to be completed.

Photo 12 Failing Ceiling Boards

Photo 13 Failing Ceiling Boards

Photo 14 Failing Ceiling Boards

Photo 15 Failing Ceiling Boards

Photo 16 Failing Ceiling Boards

In view of the above and subject to a detailed survey, we recommend loose/failing fibre board ceilings are over-boarded with plasterboard. If more than 50% of existing ceilings are dry lined with

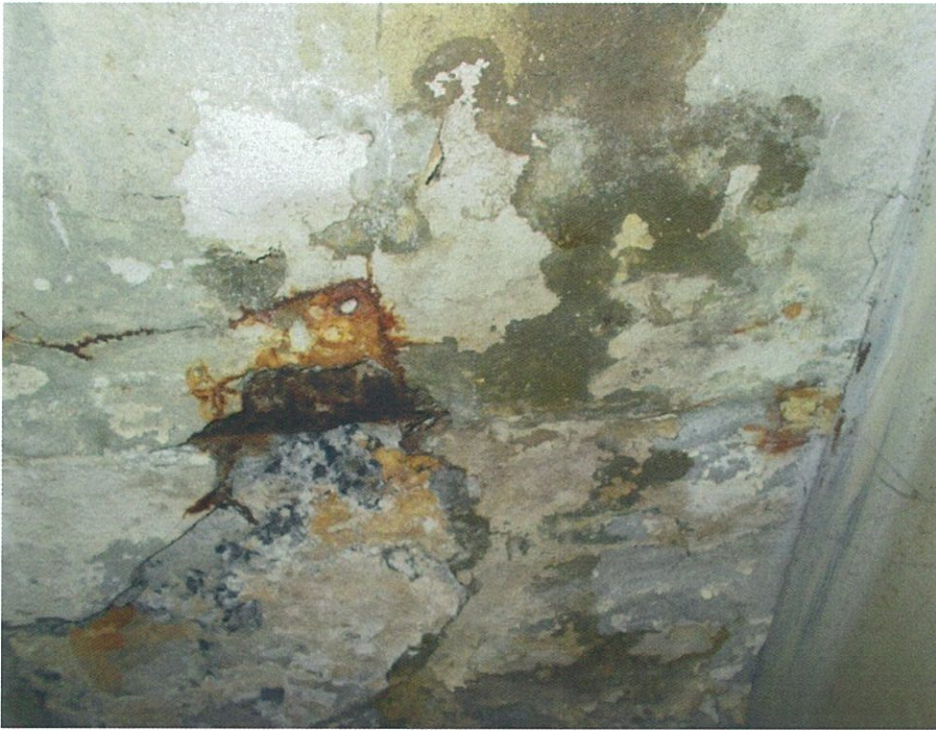
Embedded corroded steelwork was identified within the basement ceiling. Ideally steelwork and surrounding materials should be exposed, treated and repaired in-situ. If steelwork is beyond means of repair, a suitably sized replacement will be required. Temporary structural props are required to be in place during completion of these repairs. It is important to note, additional repairs may be identified as required in completing exposure works within the Basement.

Photo 17 Corrosion to Embedded Steel within Basement Ceiling

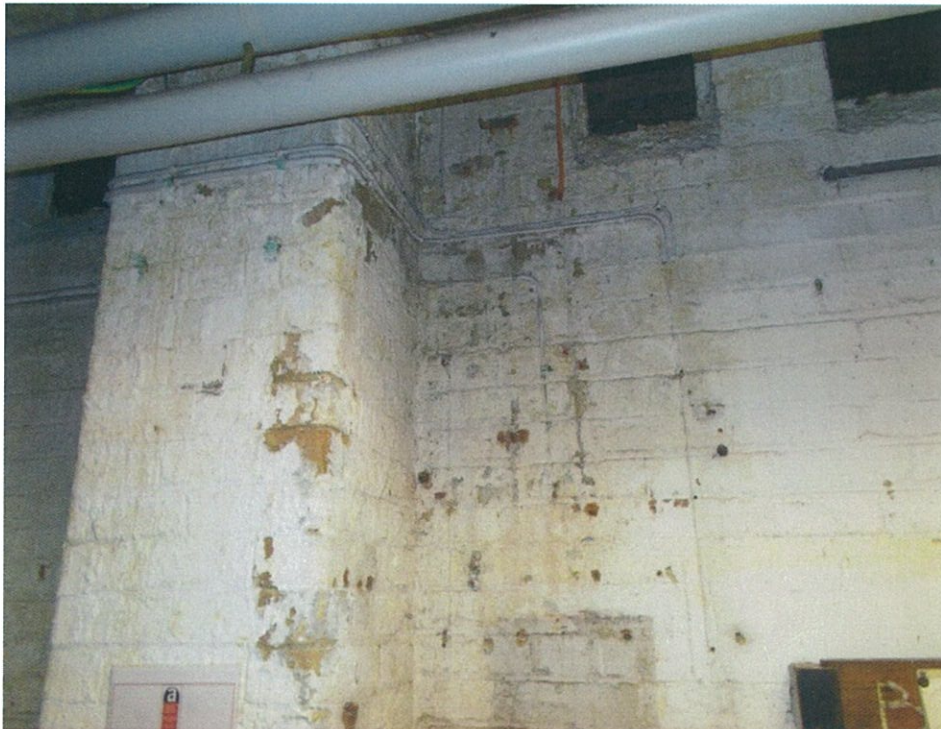
Blown and water damaged plaster is evident in various locations due to water ingress via the failing roof coverings. Evidence of continued water ingress within basement areas is widespread and there is corroded embedded steelwork within the ceiling.

Photo 18 Water Ingress into Basement

In summary walls were generally noted to be in a fair condition although basement areas should be tanked to prevent continued water ingress.

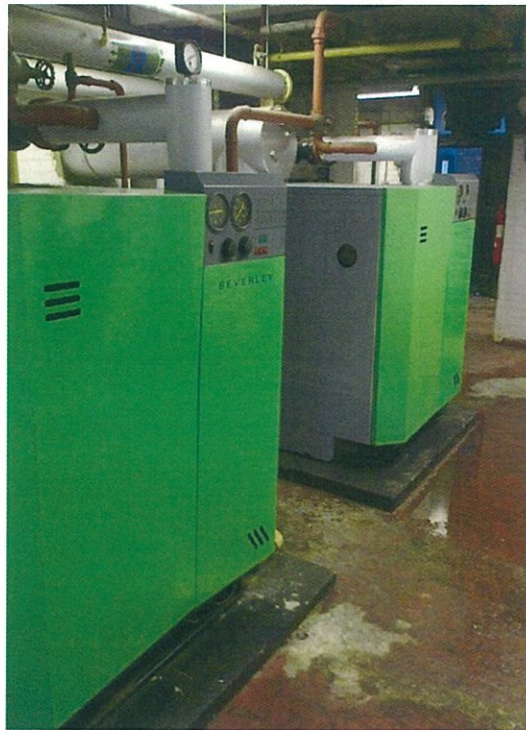
Fire fighting protection is provided by fire extinguishers, all appear to be regularly maintained and visually in good condition. The above ground drainage appears to be in satisfactory condition and there are no reported issues. Other than frequent water ingress in the basement boiler room, which likely to be connected with fabric defect.

Photo 19 Basement heating boilers, water ingress

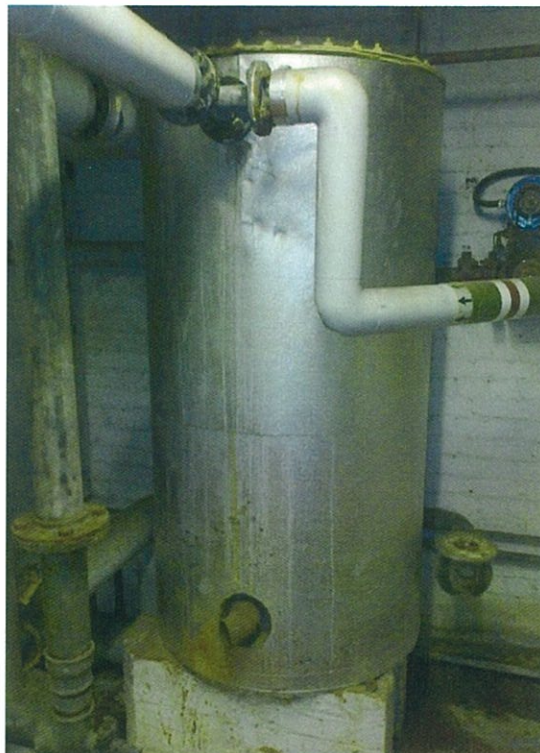
Photo 20 Basement plant room, redundant hot water cylinder

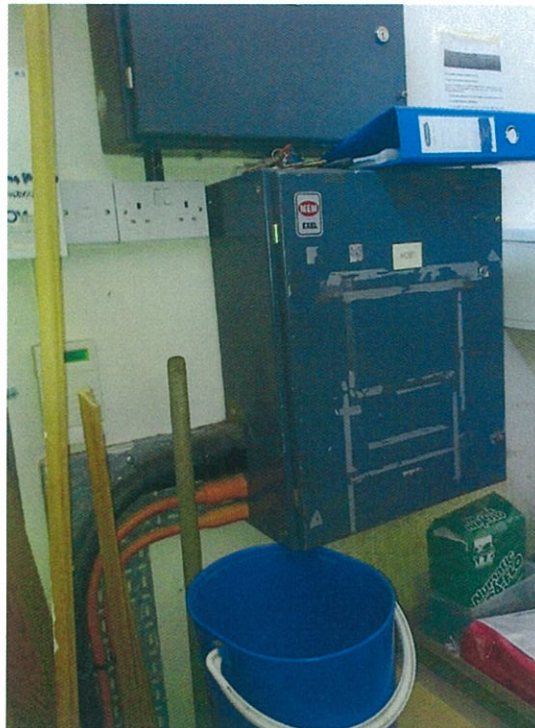
Photo 21 Local electrical distribution, in cleaner's cupboard

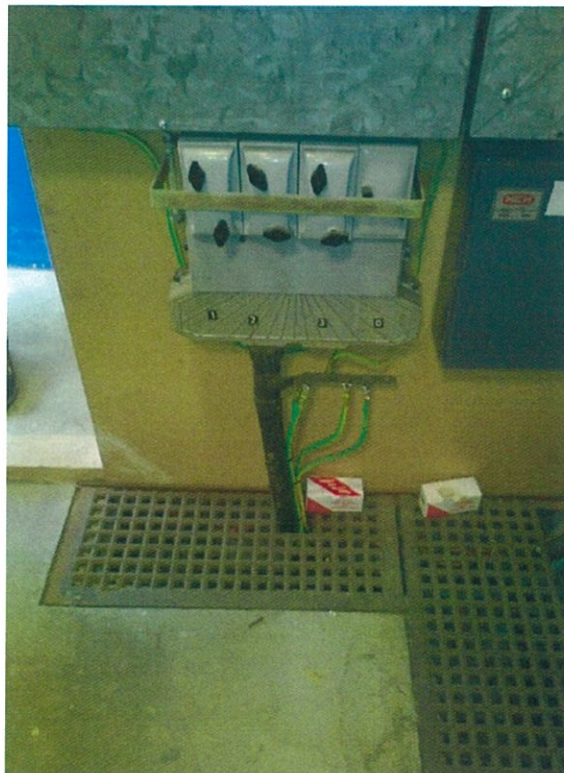
The installation had its last periodical inspection in September 2010 and installation reported to be satisfactory with no outstanding recommended remedial works. However, it was noted that no rubber matting was provided in the in electrical intake room, no circuit charts and poor labelling, recommended remedial work are carried out during routine maintenance. No major works are envisaged in the next 5 years other than routine maintenance.

Photo 22 Main electrical intake, no rubber matting on floor

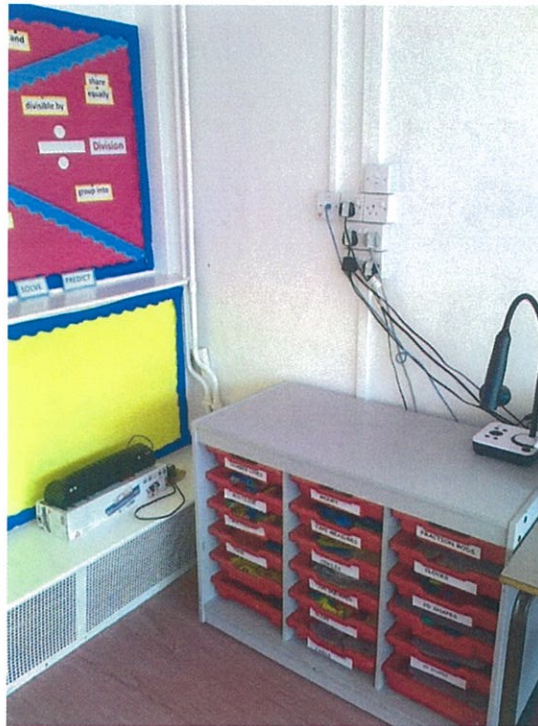
Photo 23 Classroom, small power outlets

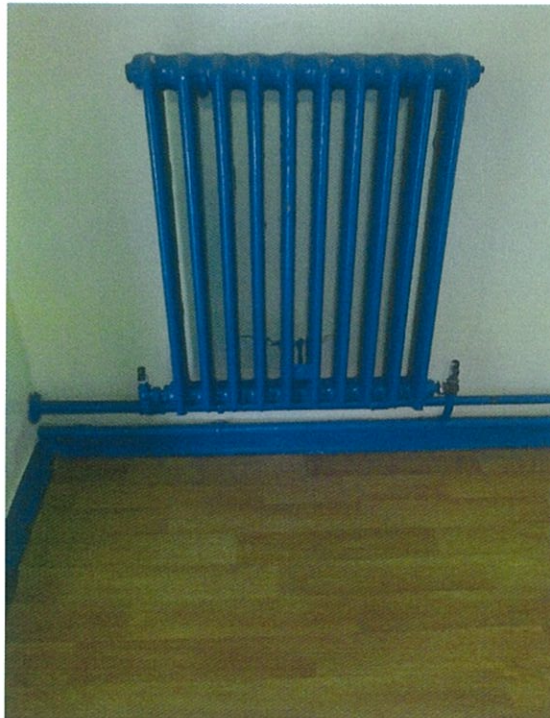
Photo 24 Radiator in circulation area, without local temperature control

Generally, the valves & cocks form part of the original mechanical services installation and visually appear to be in fair condition for their age. However, as part of improvement works, consideration should be given to installing new thermostatic radiator valves (TRV) to all cast iron radiators, throughout the school building. Also, the installation of automatic gas isolation solenoid system within the basement boiler room, incorporating all necessary safety interlocks including main isolating valve, solenoid valve, thermal links and gas knock-off should be considered within two years.

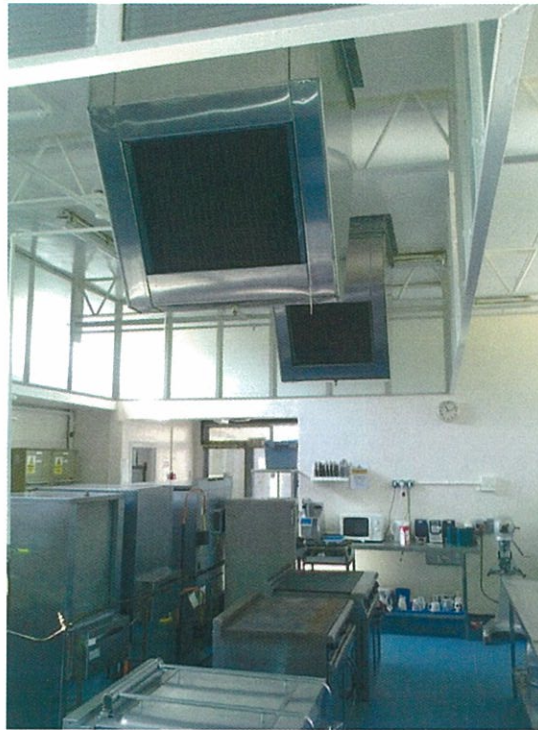
Photo 25 Main kitchen, extract ventilation to all electrical catering equipment

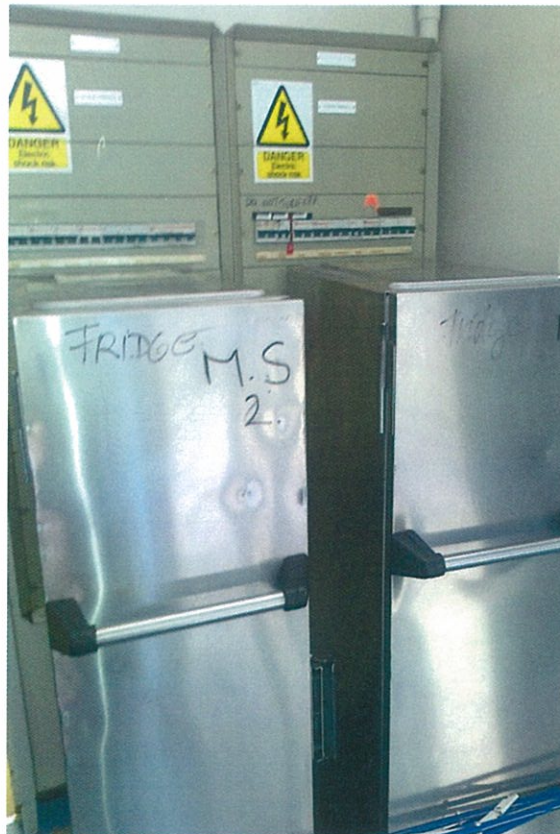
Photo 26 Main kitchen, obstructed local electrical distribution boards
