Conditions Summary Report at

Condition Summary Report at New Kings Primary

December 2012

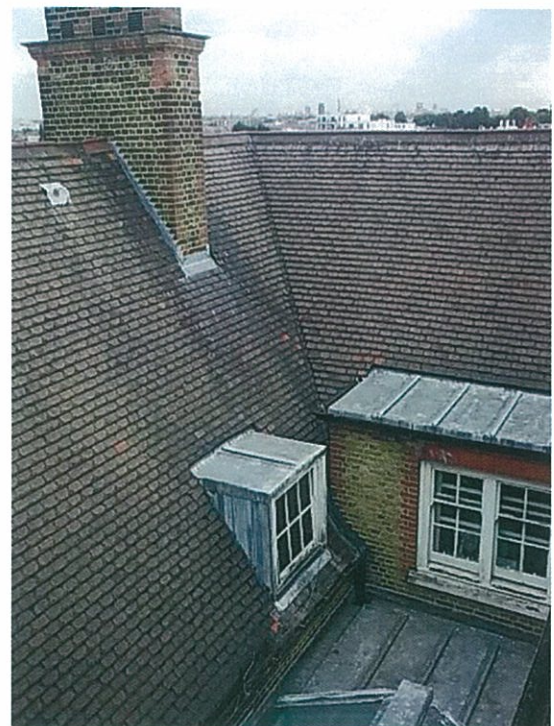
Block A – Main Roof

High and low level flat roofs of both the main building and outbuildings are finished in a combination of sheet lead and asphalt and are fast approaching the end of their useful life requiring replacement within the next 5 years.

Schools of this age and design often have inadequate flood protection at the junction of flat roof areas and roof slopes and should be improved along with the introduction of high performance rigid insulation to reduce energy consumption.

We have programmed all roof level works to be carried out together, despite the slopes having a further life expectancy of 10 years to make use of one set of scaffold access; also sloping areas of plain tile must be stripped to carry out flat roof works.

To meet the governments ever increasing carbon reduction targets we strongly recommend that all roof slopes also be insulated using a carrier system which will greatly reduce energy consumption and which has been allowed for.

Single glazed skylights and lanterns should also be replaced with double dome units to improve thermal efficiency this may however require planning permission.

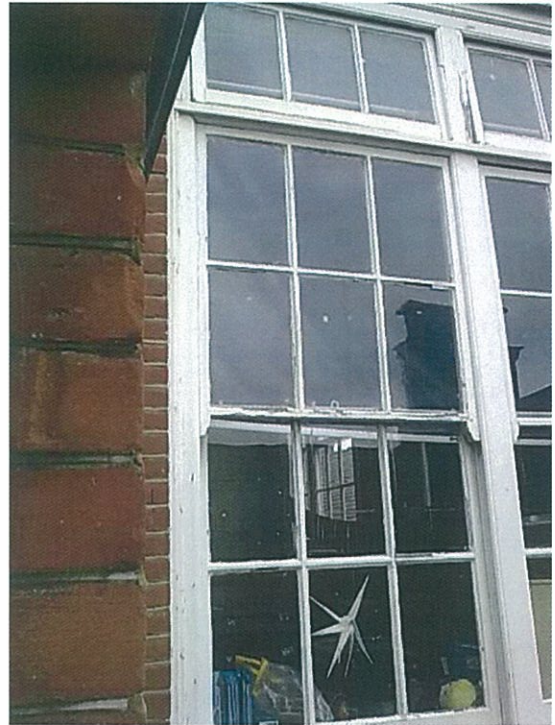
Block A – Upper Windows

Although some loft room windows have been repaired, other areas are suffering from early rot and decay and should be repaired in year 5, which would ideally be co-ordinated with roofing works.

Please note that it is most probable that lead was used in the underlying layers of paint on external windows and doors and as we are recommending repairs rather than replacement then precautions should be taken to deal with this.

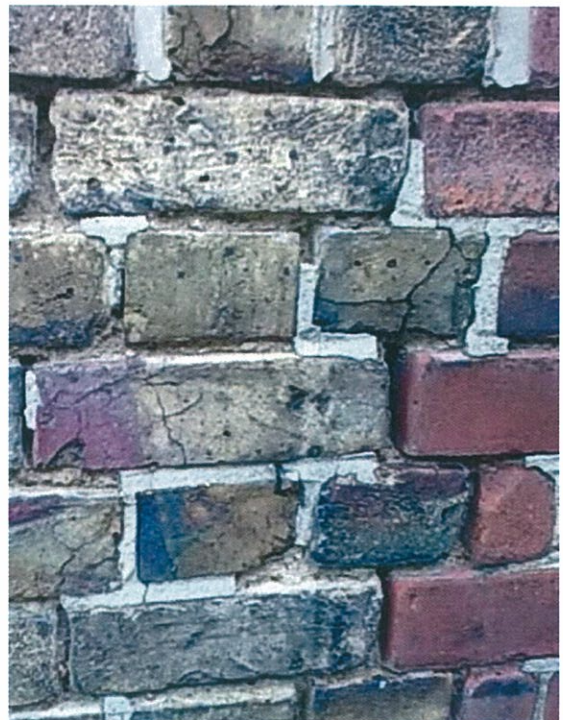
Block A – Brickwork

Although chimney stacks appear to be in fair condition, it was not possible to see all faces which may be suffering from frost attack and should be inspected as a matter of some urgency along with parapets and upper brick outside walls to check if brick faces have become loose or blown.

We also noted evidence of leaks on cast iron hoppers and rainwater downpipes which represent an even more serious risk as corrosion may have loosened them which hence should be inspected at the same time.

Some areas of high level brickwork and cast iron drainage are in need of urgent repairs as there is some risk of falling material, which may be considered by the school under their delegated budgets, ahead of possible planned works in the medium term, say 2 to 5 years, subject to budget approval.

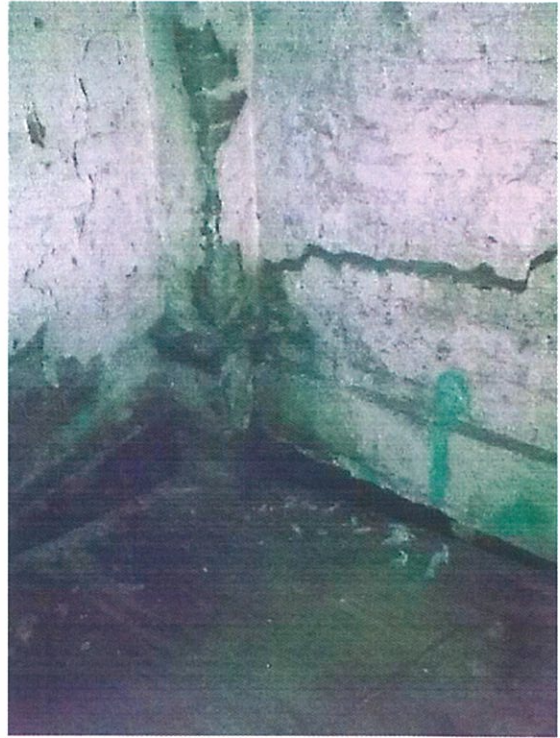
Sections of this boundary wall are showing signs of settlement and should be rebuilt on new foundations in year 2.

Struct. cracking from settlement in North boundary wall
