London Borough of Hammersmith & Fulham

6. **HAMMERSMITH LIBRARY REFURBISHMENT AND OPTION FOR
ARCHIVE SERVICE**

Feasibility Report for the Upgrade of Hammersmith Library, Shepherds Bush Road, Hammersmith, London W6 7AT

June 2012

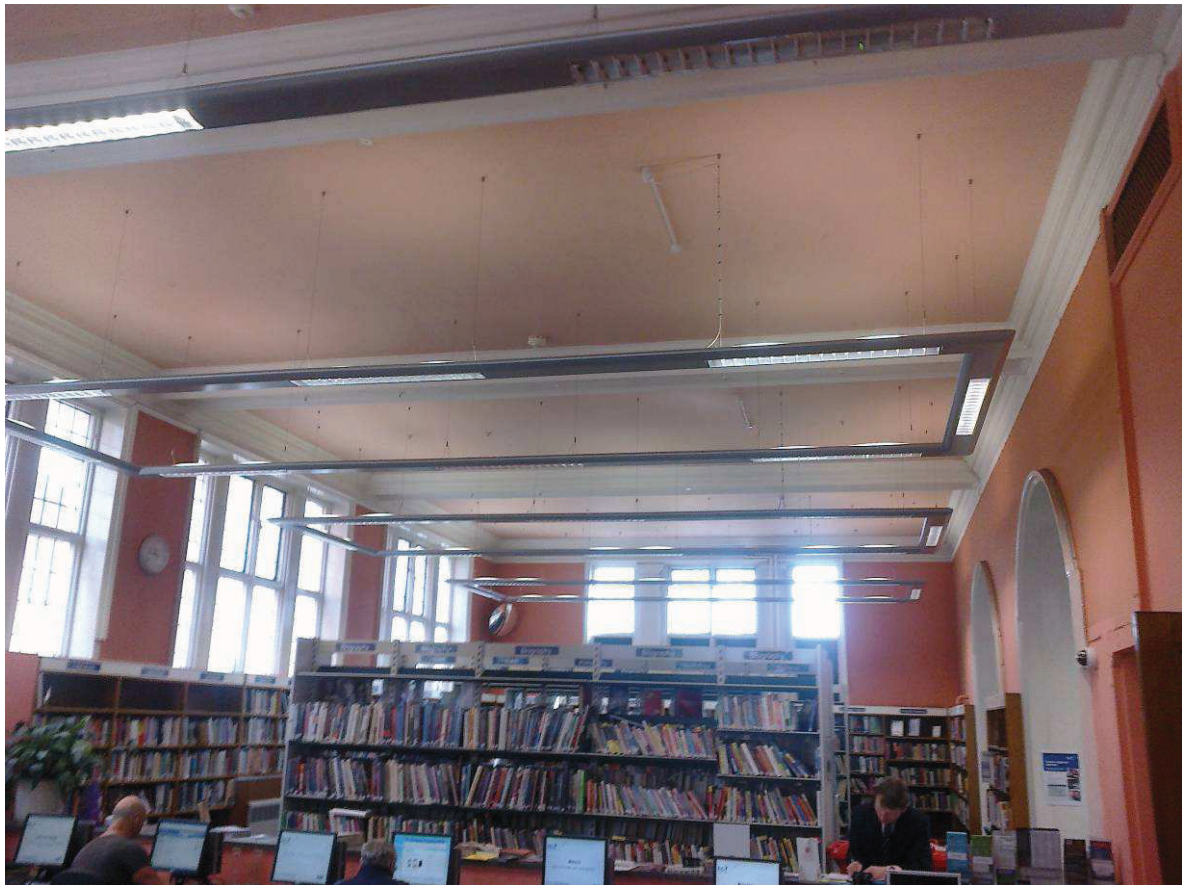
Photo 9. Study area and non fiction section – ground floor

- 4.47 The interior of the library areas (photographs 8, 9 and 10) comprises principally of a painted walls and ceilings although the walls to the main public staircase are clad in marble up to the handrail height. The finishes to the main public areas on the ground and first floor and the Chief Librarian's office are particularly ornate and include cornices etc and overall the interior of the premises is in a fair state of repair although the decorative finishes to the staff offices are now very tired.
