London Borough of Hammersmith and Fulham

Feasibility Report for the Upgrade of Hammersmith Library, Shepherds Bush Road, Hammersmith, London W6 7AT

June 2012

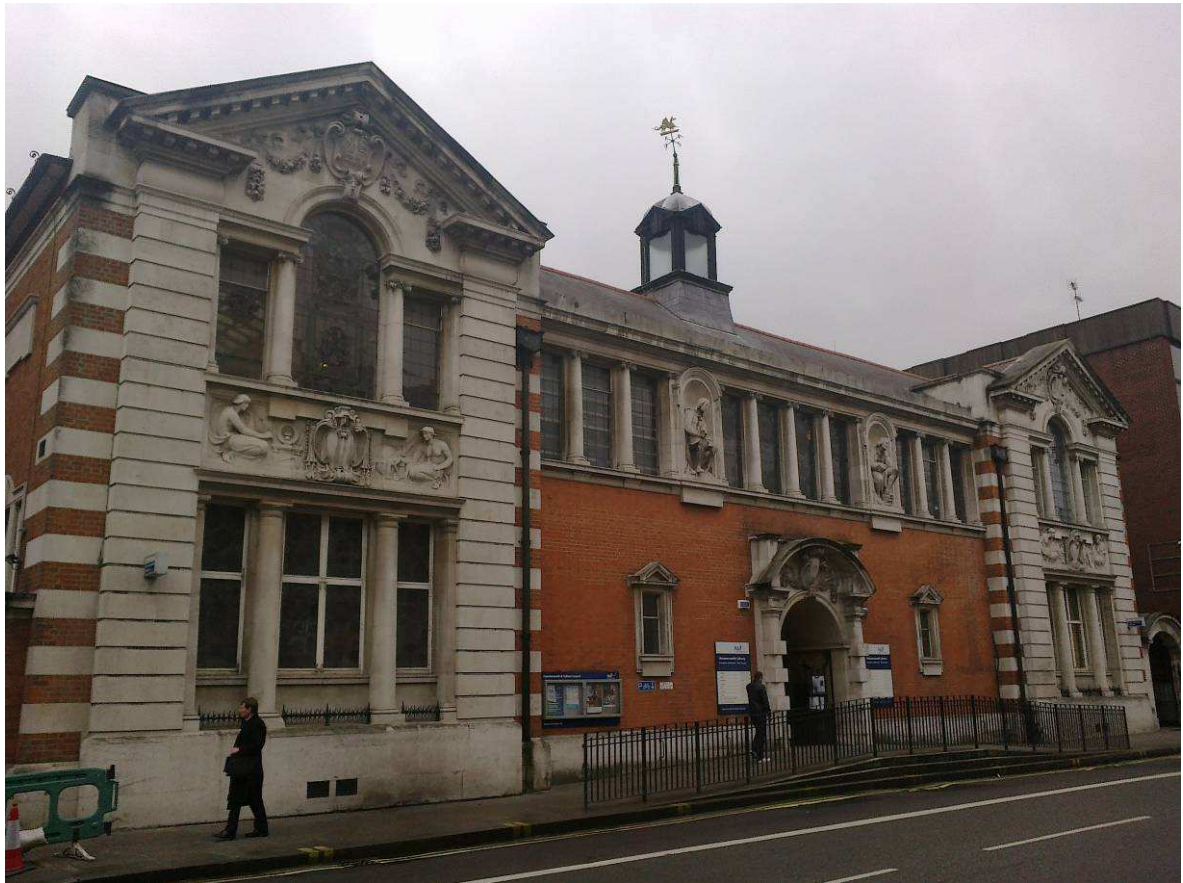
Photo 1. Front elevation

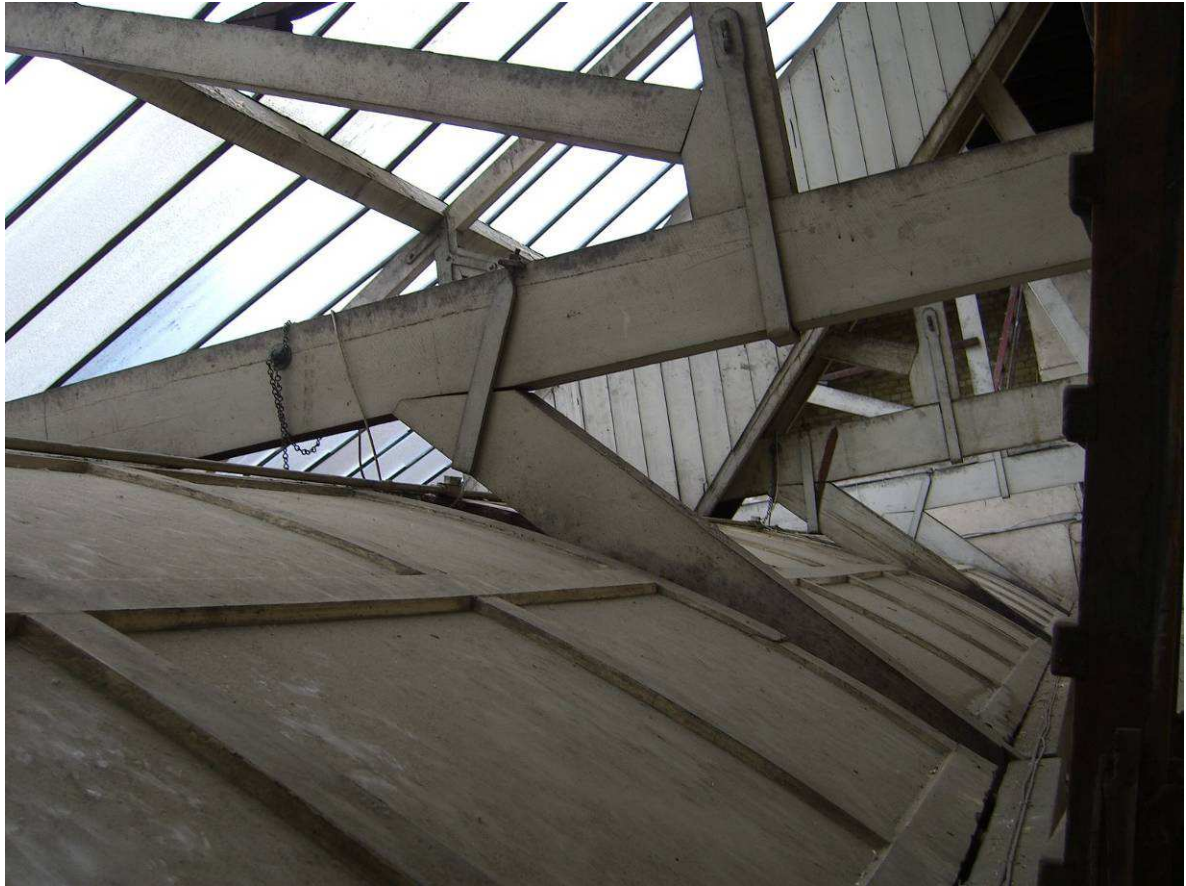
- c) Carrying out the works in a safe manner (operatives will be working at a height of two stories and will be working above the glazed roof light over the ground floor of the library (photographs 7 and 8))

Photo 7. Roof void between roof light and glazed vault over ground floor

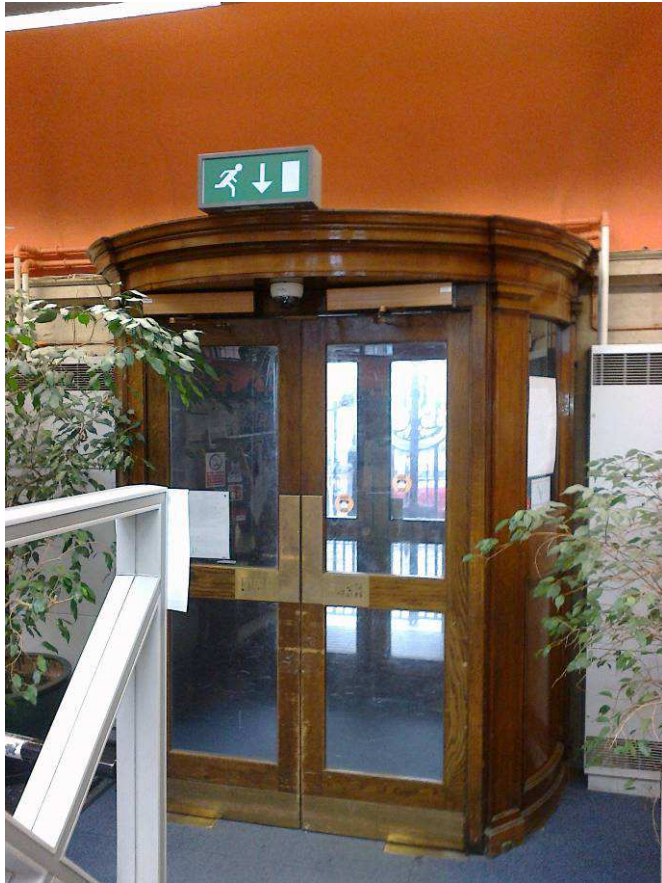
- 5.6 On 13th March LBHF advised that the automated doors (photograph 11) are functioning poorly and although the problems users experience are associated with the aesthetics and function of the doors. The entrance comprises two pairs of standard half glazed doors fitted to an enclosure within which a revolving door was originally fitted.

Photo 11. Public entrance to the library
