Condition Survey and Planned
Maintenance Schedule

Sullivan Primary School

Edward Hawkins BSc (Hons) MRICS

Date: 9th September 2013

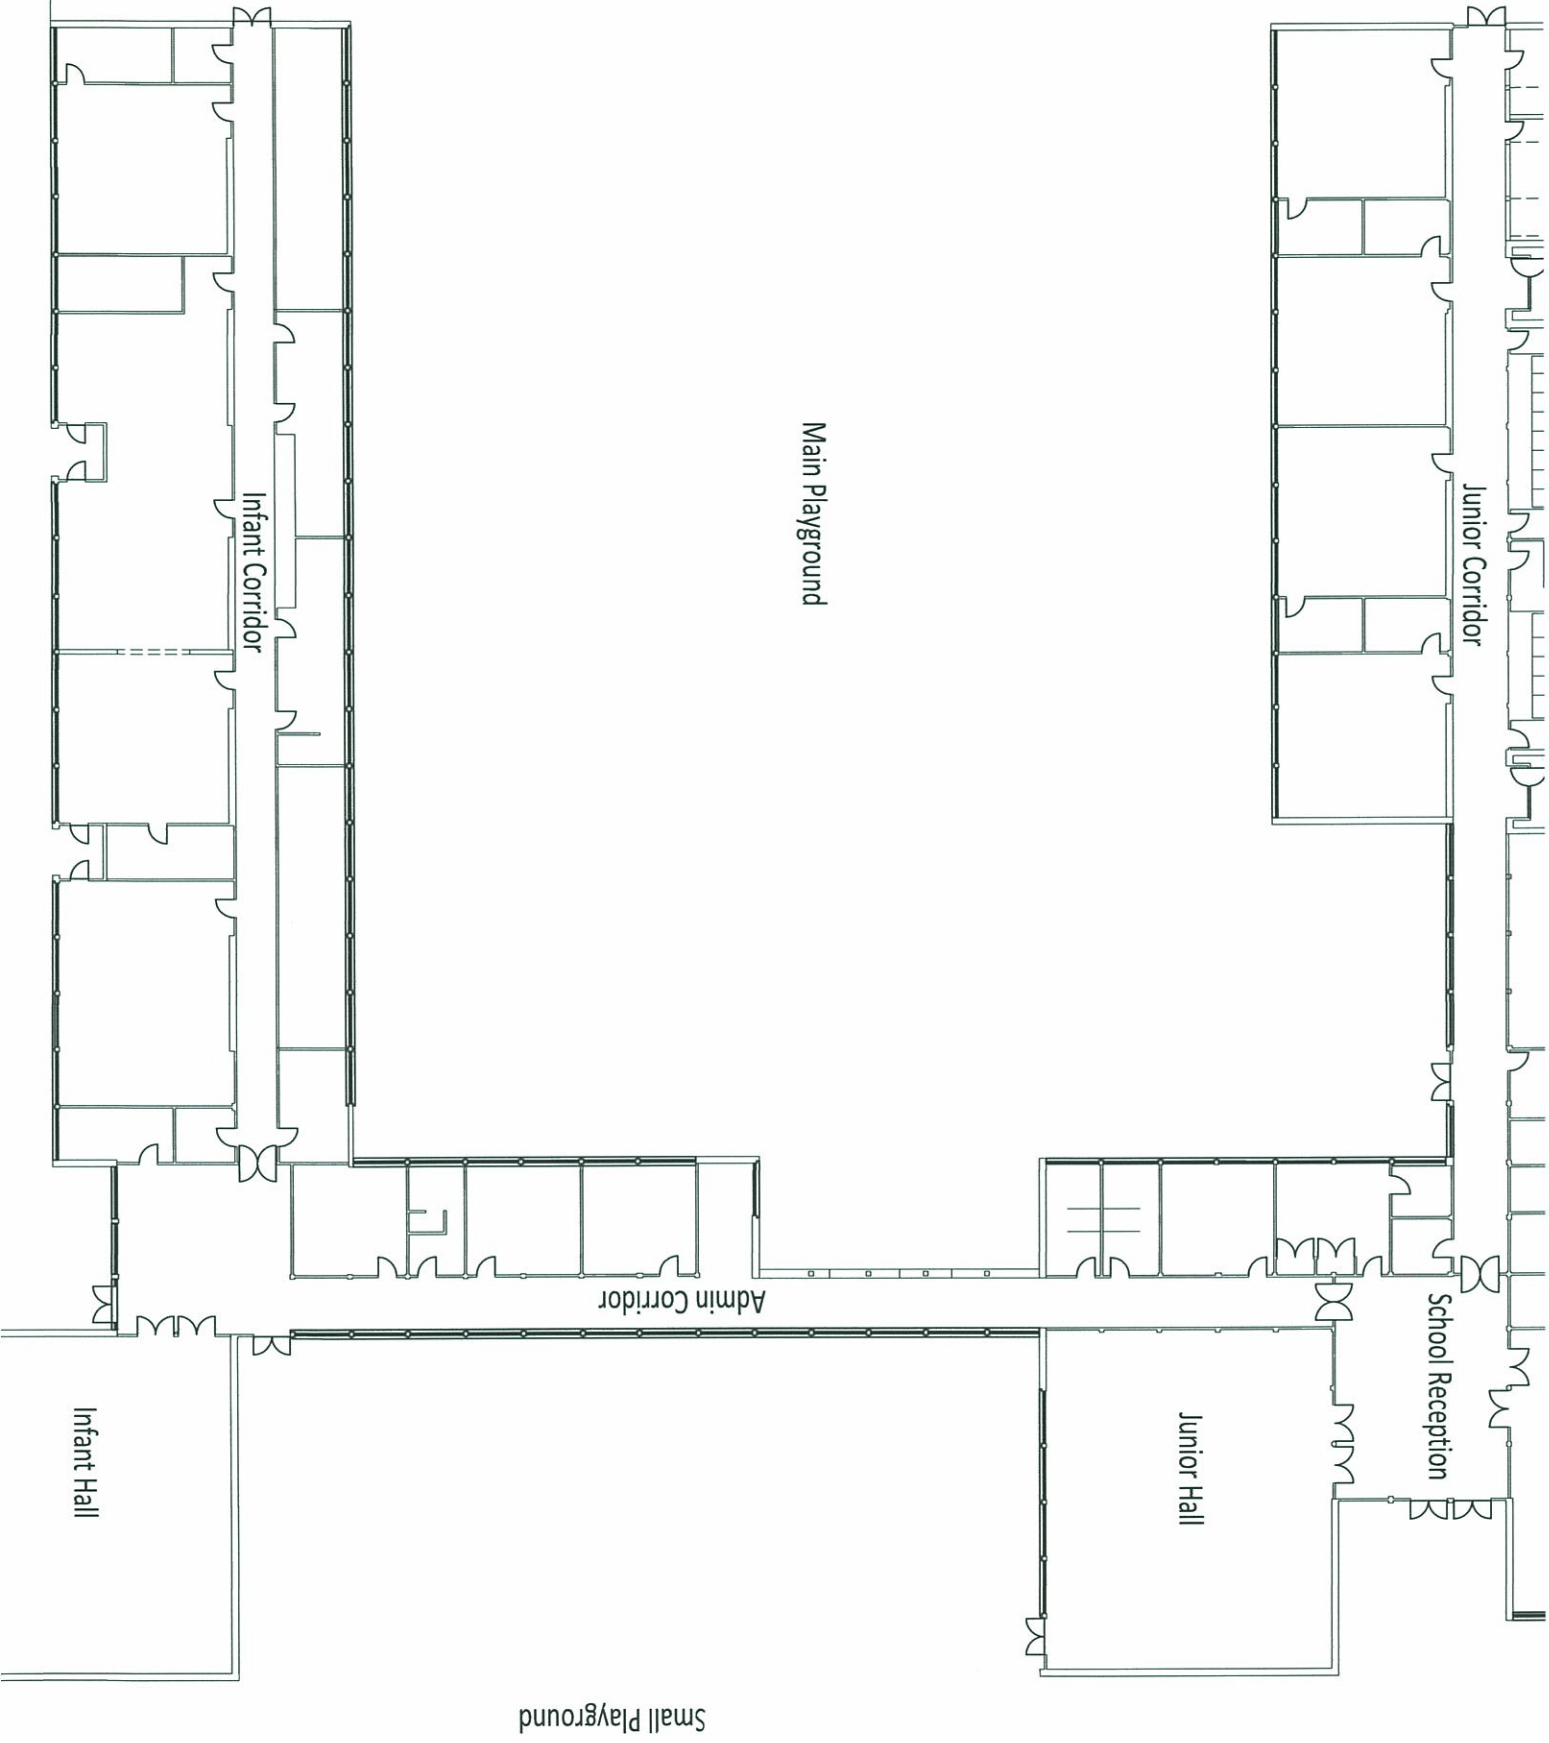
Dotted line depicts existing gutters & downpipes (DP)

- The gutters to the roof are slightly undersized and it would be beneficial to replace lengths of the existing gutters and downpipes with larger diameter sections. This work was planned for the summer but due to funding restrictions had to be omitted from the recent Roofing & Staircase core works.
