APPENDIX 3 – Hammersmith & Fulham Lighting Background

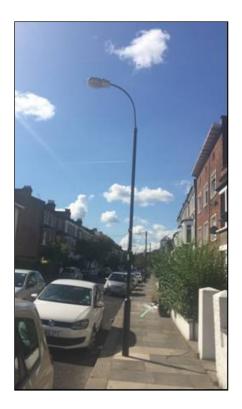
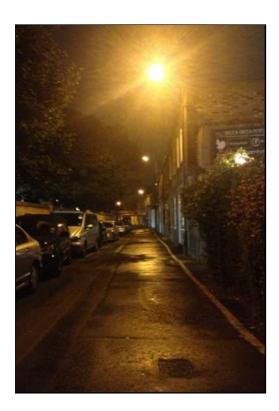
Photographs 1 & 2 – High Pressure Sodium Lamps

- 1.3. In 2007 the type of lamps used in new lighting were switched from high pressure sodium "yellow" light lamps (Photographs 1 & 2 below) to Cosmopolis "white" light lamps (Photographs 3 & 4 below). This reduced energy usage and carbon emissions because Cosmopolis lamps can produce an equivalent amount of useful light (compared to high pressure sodium lamps) using lower wattage lamps. The switch to Cosmopolis lamps also improved visibility at night. This is because white light provides better colour rendition than yellow light, as can be seen by comparing Photographs 2 and 4 below. LEDs also produce white light but are more energy efficient than Cosmopolis lamps and sold as requiring like or no routine work over the life of the lantern.
